Using electrical, magnetic and acoustic sensors to detect damage in segmental concrete pipes subjected to permanent ground displacement

Mohammad Pour-Ghaz^{a,*}, Junhee Kim^b, Srinivasa S. Nadukuru^b, Sean M. O'Connor^b, Radoslaw L. Michalowski^b, Aaron S. Bradshaw^c, Russell A. Green^d, Jerome P. Lynch^b, Amir Poursaei^e, W. Jason Weiss^f

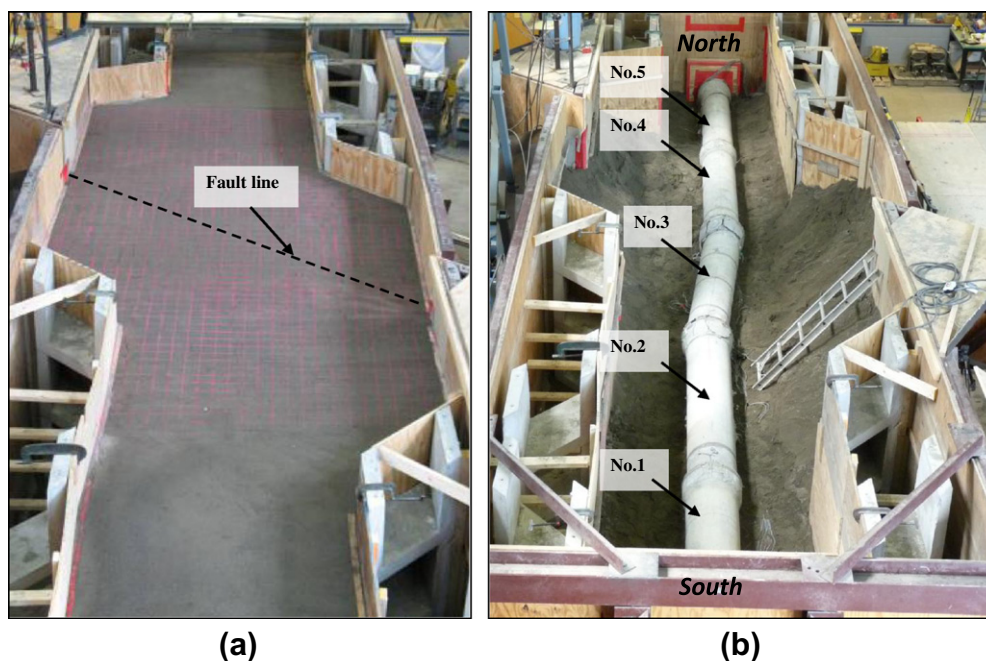
Fig. 1. (a) Test basin after backfilling, (b) full-scale segmental concrete pipeline (after excavation) tested at the large-scale testing facility at the George E. Brown, Jr. Network for Earthquake Engineering Simulation (NEES) site at Cornell University.

After the completion of the test and all of the sensor data was collected, the excavation phase began. The first 120 cm ($\approx 47 \text{ in.}$) of the soil was removed using a hydraulic clamshell bucket. The remaining backfill was removed carefully using shovels and brushes to avoid causing further damage to the pipeline. The pipeline after excavation is shown in Fig. 1b.
