# Sodium chloride crystallization in a “salt transporting” restoration plaster

B. Lubelli <sup>a,b,\*</sup>, R.P.J. van Hees <sup>a,b</sup>, C.J.W.P. Groot <sup>a</sup>

<sup>a</sup> TUDelft, Delft, The Netherlands

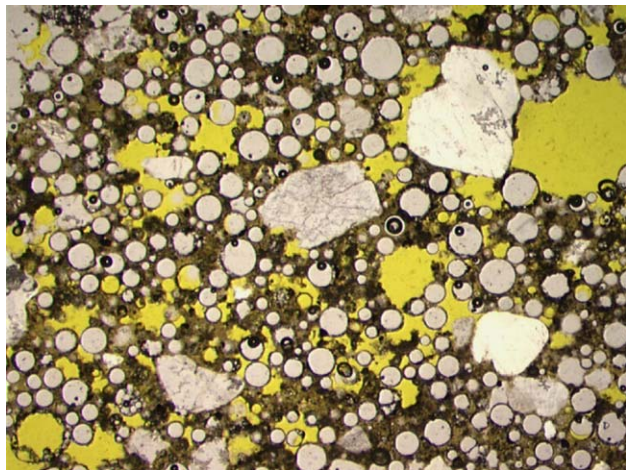
The composition of the plaster has been investigated by means of several techniques. Thin sections have been prepared to be studied by means of Polarized and Fluorescent Microscopy (PFM). This technique allows to investigate plaster composition, coarse porosity, voids and also decay in the material. Fig. 1 is a photomicrograph showing the presence of large voids between the cement binder and the aggregate. Two types of aggregate can be distinguished: a siliceous aggregate

Fig. 1. PFM photomicrograph of a thin section of the restoration plaster (25 $\times$ , picture size 5.4 $\times$ 3.5 cm).

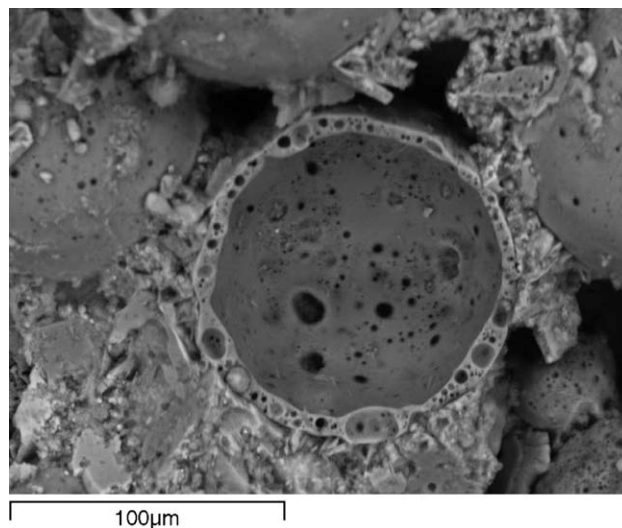
Fig. 2. ESEM photomicrograph of the hollow aggregate.

(in minor percentage) and a round hollow aggregate. This aggregate, as shown also by means of an Environmental Scanning Electron Microscope (ESEM, Philips XL-FEG SEM equipped with Secondary Electron and Backscatter Electron detectors) (Figs. 2, 3) seems not connected to the porous network, and represents the closed porosity of the plaster. The hollow aggregate, as shown by XRD analyses, is constituted by mullite ( $\text{Al}_4\text{Si}_2\text{O}_{10}$ ).

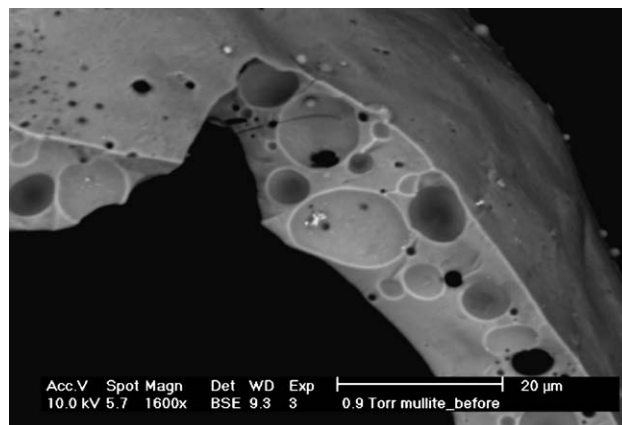
Fig. 3. ESEM photomicrograph of the walls of the hollow aggregate.

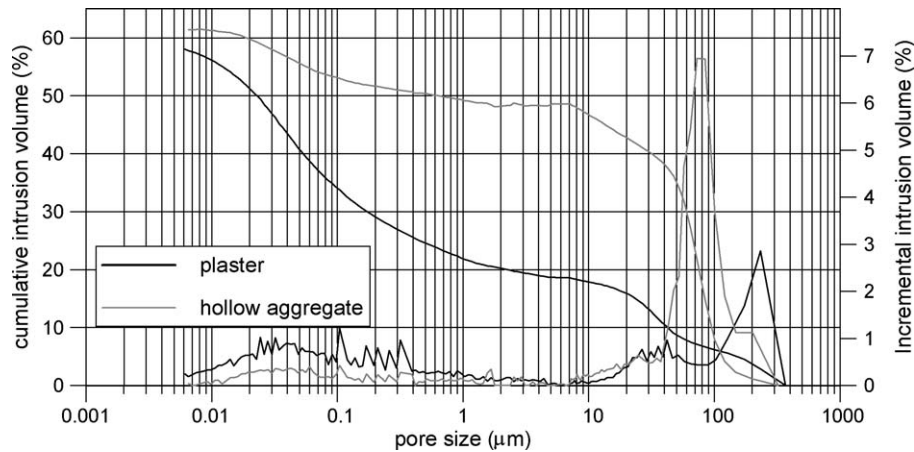
Fig. 4. Pore size distribution of the restoration plaster and of the hollow aggregate as measured by MIP.

The open porosity of the restoration plaster measured by MIP turned out to be 58% V/V. The porosity is mainly constituted by large ( $>10\ \mu\text{m}$ ) and by very small pores in the range of capillary condensation ( $<0.1\ \mu\text{m}$ ). Some questions arise when considering the very high value of porosity: either damage (the hollow spheres may be broken due to the pressure developed in the MIP) or deformation of the structure can be supposed. Both explanations are likely to show up in the cumulative intrusion curve as a steep increase in the range of the smaller pores. To further check these results, MIP measurements were performed on the hollow aggregate, after separating it from the binder. Again a very high porosity was registered (Fig. 4), probably due to breaking and filling of the hollow spheres. The fine pores present on the mullite walls (Fig. 3) may also contribute to the amount of fine porosity. From the MIP measurements it can be concluded that only part of the fine porosity measured in the plaster is due to the binder; the rest is most probably due to the mullite spheres.

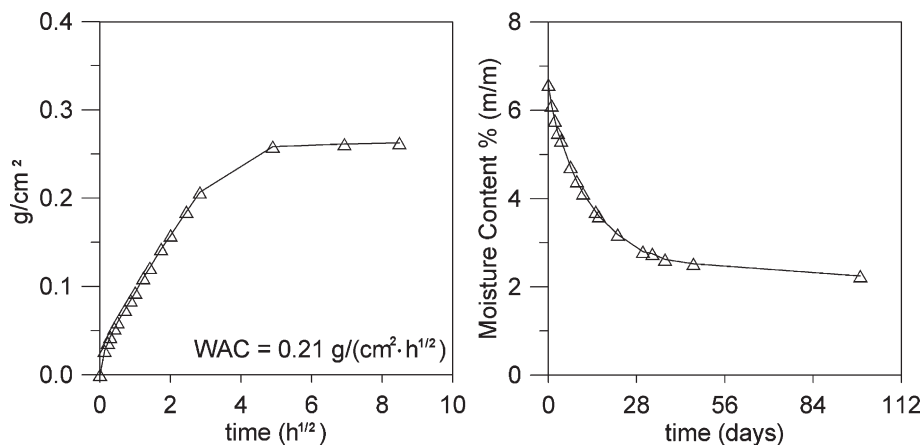
The pore size distribution of the material strongly influences its absorbing and drying behaviour: because of the presence of small pores, the plaster shows a slow absorption and drying (Fig. 5). Besides, the presence of cellulose, that can retain water even in secondary moistening, further slows the drying. It is

Fig. 5. Absorption (left) and drying (right) behaviour of the restoration plaster.

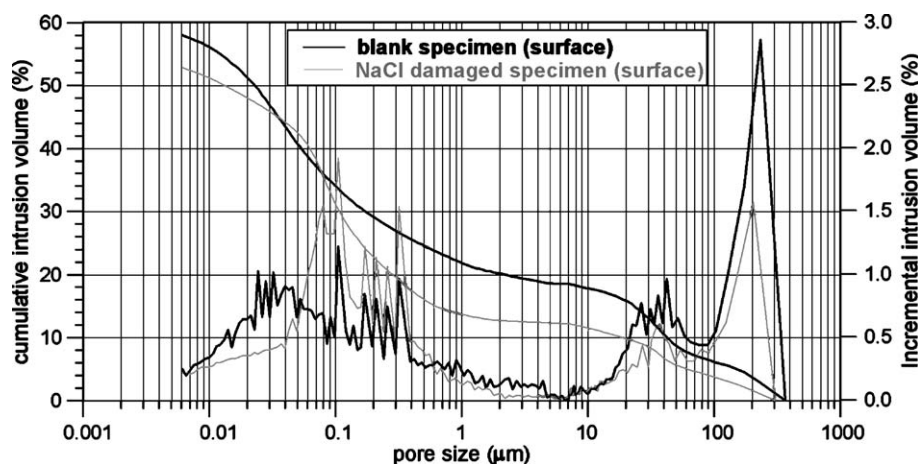
Fig. 6. Pore size distribution of the restoration plaster, before and after contamination and crystallization, as determined by mercury intrusion porosimetry.

The pore size distributions obtained are shown in Fig. 6: a decrease in the percentage of pores smaller than 0.05 μm and larger than 0.5 μm as well as an increase in the percentage of pores in the 0.05–0.1 μm range is measured after crystallization.
