Extended studies of degradation mechanisms in the refractory lining of a rotary kiln for iron ore pellet production

Jesper Stjernberg^{a,*}, John C. Ion^a, Marta-Lena Antti^a, Lars-Olof Nordin^b, Bo Lindblom^b,
Magnus Odén^c

Changes, over a period of 8 years, in the chemical composition and morphology of deposit and lining materials in a production rotary kiln for iron ore pellet manufacture are described. The following have been studied: two types of refractory brick used as lining material; deposited chunk materials from the lining; the interaction zones between deposits and linings. Morphological changes at the deposit/lining interface, and the active chemical reactions, are established. Larger hematite grains in the deposit material (5–50 µm) primarily remain at the original deposit/lining interface. The remainder penetrates fissures, voids and brick joints, forms a laminar structure with corundum from the bricks, and migrates in grains in the lining material. Potassium penetrates more deeply into the bricks than hematite, resulting in the formation of kalsilite, leucite and potassium β-alumina, which contribute to degradation of the lining.

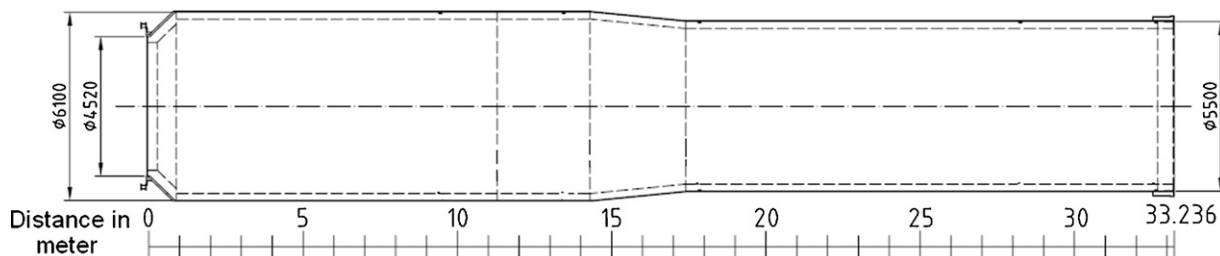
The kiln studied here rotates clockwise (observed from the outlet) at approx. 2 rpm, and is tilted 3° to the horizontal plane such that the pellets travel more easily towards its outlet, through a helical movement. Fig. 2 shows the design of the kiln. It has a length of 33.2 m, and an inner diameter of 5.64 m at the inlet

(where the feed enters) and 5.04 m at the outlet (dimensions in the drawing are the outer diameter of the refractories at the steel shell). A burner is located at the outlet of the kiln. It is primarily fuelled with coal, but oil is used at start-ups and if problems in the feed of coal arise. The length of the flame and the location of the hot spot formed vary with the fuel used. This can cause thermomechanical tensile stresses in the lining, resulting in thermally induced lining spallation.⁴ A scheduled production stop of the kiln takes place once a year, to remove deposits and replace depleted refractory bricks. The removal of these deposits causes abrasive wear that also degrades the lining.

Fig. 2. Schematic diagram of the KK2 kiln located in Kiruna, Sweden.
