# Observation of the Fracture Path Development in Mortar Beam Specimens

*The development of the fracture zone in beam specimens subjected to three-point and four-point bending has been observed and was related to the overall load-deflection relationship. A video technique together with the computer scanning facility were used to detect the initial macrocracks appearing before the attainment of the maximum load and also to record the fracture path formation in the postpeak portion of the load deflection curve. A comparison is made between unnotched and notched beams that are prepared for fracture testing from the standard size concrete beams. Due to its simplicity and cost effectiveness, this technique could be applied in many practical situations to detect the initial critical cracks and to reexamine the test results on the repetitive basis. ADVANCED CEMENT BASED MATERIALS 1996, 3, 31-36*

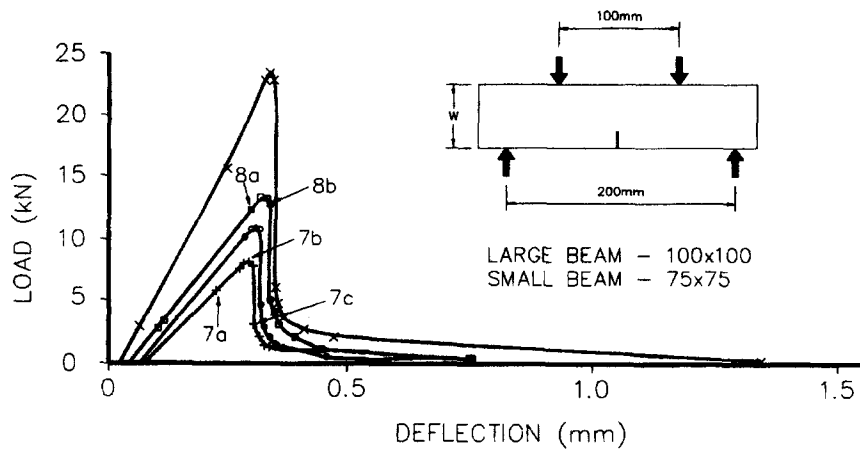
**FIGURE 6.** Load-deflection curves for four-point bending experiments.  $\circ$ , No slot, small beam;  $\times$ , no slot, large beam;  $+$ , 15 mm, small beam;  $\square$ , 20 mm, large beam.

ratios of depth:span and notch depth:depth have been used as described in the three-point bending experiments. The test results shown are the average values obtained from six experiments carried out on each beam geometry and the notch arrangements. Table 2 is a summary of the average first crack and maximum loads. Figure 6 shows typical load deflection curves for the beams.

Figure 7 shows photographs of the overall map of the crack development in 75 × 75 × 200-mm beams. A crack path is considerably inclined, and there are signs of a crack branching at the tip of the crack. The cracking process is related to the load-deflection response in Figure 6 by points 7a, 7b, and 7c.

Figure 8 depicts a typical crack development as observed in 100 × 100 × 250-mm beams (points 8a and 8b in Figure 6). The crack path was less curved and the singular inclined cracks appeared within the ligament. These cracks grew with the increasing stress until their length reached the state of mechanical instability followed by macroscopic fracture and failure. Figure 8 represents an overall map of damage.
