Repair evaluation of concrete cracks using surface and through-transmission wave measurements

Abstract

Keywords: Concrete; Characterization; Cracks; Repair; Ultrasound

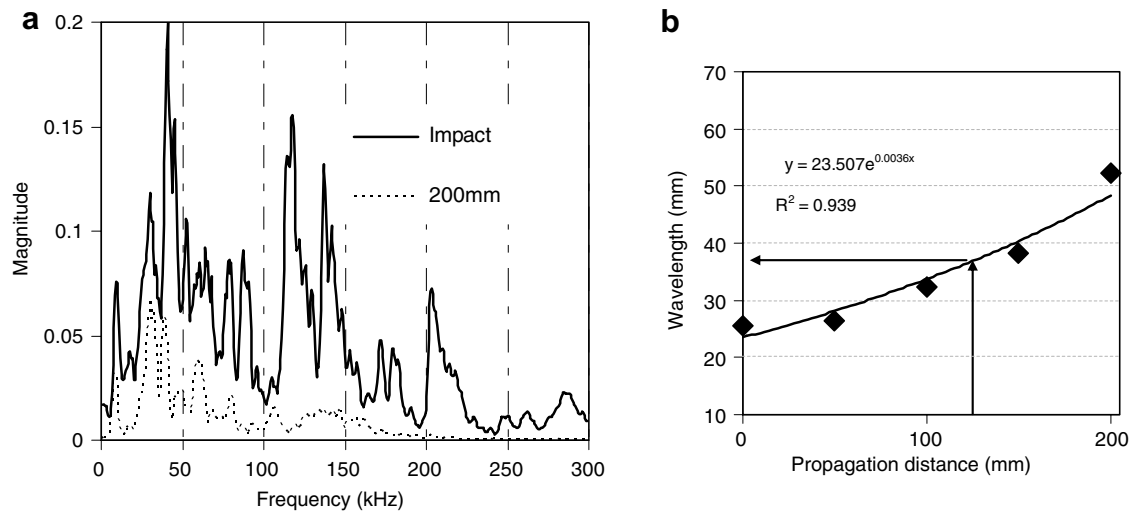
Fig. 10. (a) Fast Fourier transform of signals collected near the excitation point and 200 mm away and (b) wavelength of Rayleigh waves vs propagation distance for sound concrete.

Specifically, in Fig. 10a, the fast Fourier transforms of the responses at different points are depicted. Above 300 kHz the energy is negligible. The central frequency of

the pulse measured exactly after the excitation, see impact in Fig. 10a, is about 115 kHz, while as obvious for the distance of 200 mm the frequency content is not only smaller but also translated to the lower frequencies. In order to exclude the possibly “ringing” behavior of the sensor it may be more reliable to focus only on the first strong Rayleigh peak in time domain. This peak gets broader with propagation as seen in Fig. 5a (t_1 and t_2). At the point of impact, the duration of the peak t_1 is approximately 4.4 μ s, corresponding to period of 8.8 μ s and a frequency of around 113 kHz. At the distance of 200 mm the peak is $t_2 = 11.6 \mu$ s broad (period of 23.2 μ s) corresponding to a central frequency of approximately 43 kHz. Therefore, using the peak duration of all five positions and considering a representative Rayleigh velocity of 2600 m/s, the average wavelength changes from about 23 mm to 50 mm after 200 mm of propagation through sound material, as seen in Fig. 10b. For the specific setup, in case of excitation at point 6, see Fig. 2, the propagation distance until the wavefront faces the crack is 125 mm. From the above it is realized that the representative penetration depth of Rayleigh wave at that point is of the order of 37 mm. This is an interesting quantification feature, since if the Rayleigh peak can be observed after the crack is repaired, it implies that the surface portion of 35–40 mm was substantially filled. It is noted however, as a limitation of Rayleigh application on structures with finite depth, that Rayleigh waves do not form at depths greater than half the beam depth as energy is distributed to other modes [20].
