# Corrosion protection performance of High Performance Fiber Reinforced Cement Composites as a repair material

Keywords:
HPFRCC
Fiber content
Patch repair
Surface coating
Chloride-induced corrosion
Durability

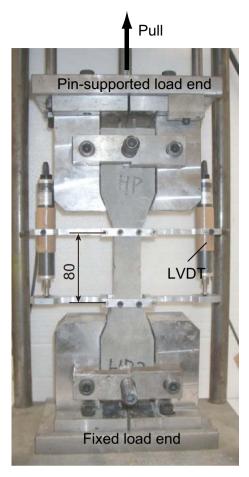
The loading apparatus used for the uni-axial tensile test is shown in Fig. 2. Following the JSCE standard [1], the lower end was fix-supported and the upper end was pin-supported. Displacement transducers were set with a gauge length of 80 mm. The loading was controlled based on the displacement.

Fig. 2. Uniaxial tension test setup [1] (unit: mm).

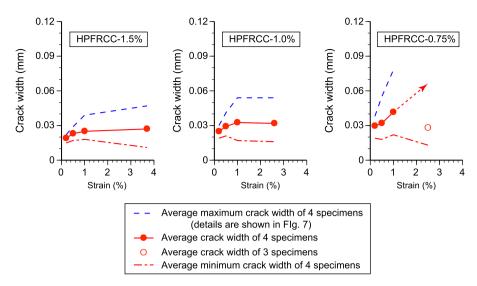
Figs. 4–7 show the average crack width, the number of cracks, the average crack spacing, and the maxim crack width of each of the HPFRCC specimens when the strain was 0.2%, 0.5%, 1.0%, respectively, and after the specimens were unloaded. In all the specimens, the average crack width was within 0.05 mm, and the number of cracks in the gauge area was more than 20. It should be noted here that one of the four HPFRCC-0.75% specimens ruptured during the loading test when the strain exceeded 1% and the crack width measurement was not possible for this specimen. Hence there is a drop in the average crack width of the HPFRCC-0.75% specimens in Fig. 4. The phantom line in Fig. 4 shows an estimated average crack width of the HPFRCC-0.75% specimens if the measurement had been carried out to all of the four specimens.

Fig. 4. The effect of fiber content on the average crack width.

steel and the double-layer structure (see Figs. 4 and 7). Detailed properties of cracks will be discussed in Section 3.7.

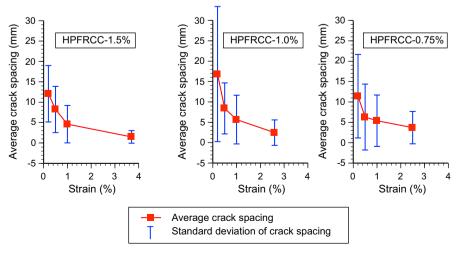
Fig. 6. The effect of fiber content on the average crack spacing.

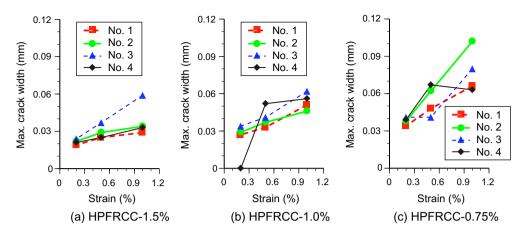
The specimens with a smaller amount of fiber had fewer cracks but a larger average crack width and maximum crack width when the strain was 1.0%. To be specific, the average crack width and the maximum crack width of HPFRCC-0.75% were 1.5 times larger than those of HPFRCC-1.5%. Furthermore, the HPFRCC-0.75% specimens unloaded after the tensile test had a much fewer number of cracks and a large average crack spacing. Therefore, the reduction in the ductility of HPFRCC specimens with lower fiber contents can be attributed to the smaller number of cracks generated during the tensile test.

Fig. 7. The effect of fiber content on the maximum crack width.

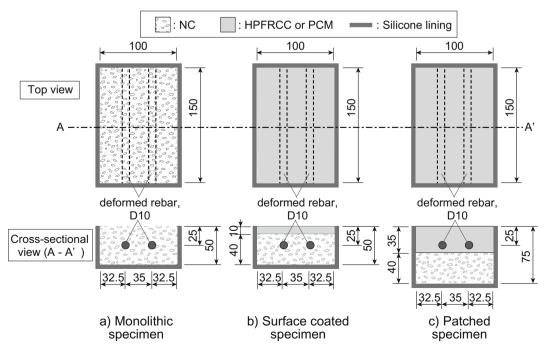
Fig. 8 shows the specimens used for the investigation of corrosion protection performance. For all the specimens, D10 rebar was used. Monolithic specimens consist of NC. They were prepared in the form of RC beams with a cross section of  $50 \times 100$  mm and a length of 1800 mm, which were then pulled to produce cracks (see Section 3.3) and cut into small specimens with a length of 150 mm. Surface coated specimens simulate a surface coating by HPFRCC. Initially, RC beams of NC with a cross section of  $40 \times 100$  mm and a length of 1800 mm were prepared as the

Fig. 8. Corrosion test specimens taken out from RC beams (unit: mm).

To let the chloride penetrate into the specimens only from the upper side, the other five sides were sealed with silicone (see Fig. 8). Then a 3% chloride solution was sprayed on the specimens for 5 min every 6 h to accelerate the deterioration.

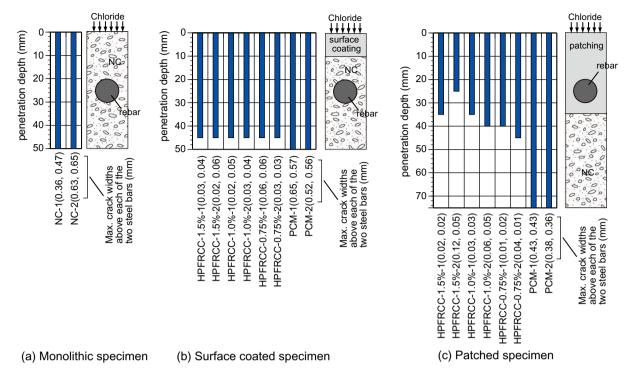
Fig. 11 shows examples of the results of the chloride penetration test in which a silver nitrate solution was sprayed on the fresh split surfaces of the specimens. It is clear from this figure that the chloride has penetrated through the cracks. Fig. 12 shows the chloride penetration depths that were determined based on the color change caused by the silver nitrate solution. The penetration depth was measured at the crack(s), and in the case with the HPHFCC specimens, the penetration depth shown here is the largest one of the penetration depths measured at plural cracks.

Fig. 12. Chloride penetration depth in specimens.

Whereas the chloride had reached the bottom surface of the specimen through the cracks in the PCM-patched specimens, the chloride penetration depths were as small as 25–45 mm in the HPFRCC-patched specimens (see Fig. 12c). It has been reported that the threshold crack width is 50–100  $\mu$ m for water permeability [11,12] and 200  $\mu$ m for chloride permeability [13,14]. The width of the cracks generated in the HPFRCC in this study was smaller than 100  $\mu$ m in most of the specimens (see Table 6), and this is considered to be the reason for the small chloride penetration depth in the HPFRCC-patched specimens.

In all of the surface coated specimens including those with HPFRCC, the chloride had almost reached the bottom of the specimens (see Figs. 11a and 12b). This leads us to conclude that the 10 mm thickness of HPFRCC was insufficient to prevent the chloride from reaching the substrate. Once it reaches the substrate, it

Fig. 13 shows the ratio of corrosion area on the reinforcing bars. Since two bars were arranged in each specimen, two results are shown for each specimen in the figure. In the NC monolithic specimens with large cracks, the ratio of corrosion area on the reinforcing steel was relatively large (see Fig. 13a). This is attributable to the large chloride penetration depths in these specimens as shown in Fig. 12.

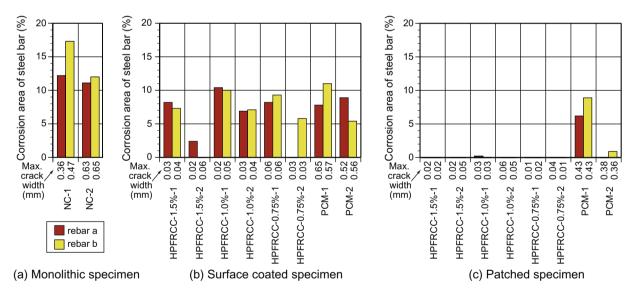
Fig. 13. Corrosion areas on the two steel rebars in each specimen.

As for the surface coated specimens, corrosion was observed in almost all the bars, regardless of the type of overlaid mixture (see Fig. 13b). This is attributable to the large chloride penetration depth. Moreover, it is supposed that the large crack opening in the substrate NC part caused to create a debonding crack between the reinforcing bars and NC, allowing the chloride to penetrate farther along the interface between rebar and concrete.

The PCM-patched specimens failed to show sufficient corrosion prevention performance. As shown in Fig. 13c, the corrosion area ratios of the reinforcement in a PCM-patched specimen were as large as from 6% to 9%, whereas these values were smaller than those of the monolithic NC specimens. In contrast, the HPFRCC-patched specimen did prevent the steel corrosion, although it

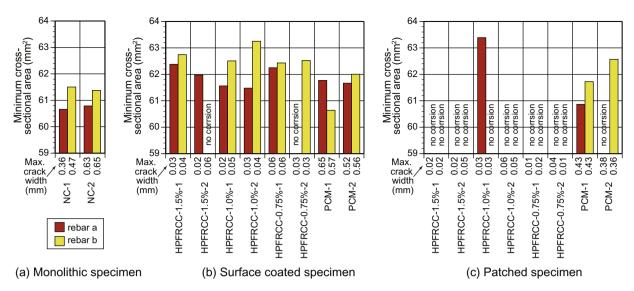
Fig. 14. The minimum cross-sectional area of each rebar.

The strength of the reinforcing bar is largely dependent on the minimum cross-sectional area of the bar. Therefore, Fig. 14 shows the minimum cross-sectional area of each corroded rebar calculated from the cross-sectional area distribution obtained using a 3D scanner. Here, the cross-sectional area profiles of the bar without corrosion were not measured. It should be noted that the bars used in this study were deformed bars with the mill scale and that there are large variations in the cross-sectional area of bars even without corrosion. Similarly to the corrosion area ratio, the loss of the cross-sectional area was the largest in the NC monolithic specimens (see Fig. 14a). As for the surface coated specimens, it can be recognized that the corrosion progressed into the depth direction from the steel surface even though the HPFRCC was overlaid on the substrate (see Fig. 14b). On the contrary, hardly any cross-sectional area loss of bars was detected in the HPFRCCpatched specimens (see Fig. 14c), which again confirms the high applicability of HPFRCC as a patch repair material.
