## Effect of aging on bond of GFRP bars embedded in concrete

Mathieu Robert \*, Brahim Benmokrane

Department of Civil Engineering, University of Sherbrooke, Sherbrooke, Quebec, Canada J1K 2R1

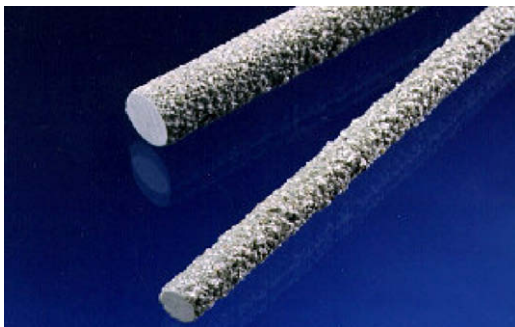
Fig. 1. Surface configuration of a GFRP bar.

Sand-coated GFRP bars manufactured by a Canadian company (Pultrall Inc., 2005) were used in this study (Fig. 1). The GFRP reinforcement was made of continuous longitudinal E-glass-fiber strands bound together with a thermosetting vinylester resin using a pultrusion process. A coating of sand particles of a specific grain-size distribution further enhances the bonding potential. The glass's mass fraction was 78.3%, determined by thermogravimetric analysis according to ASTM E 1131 [4]. The relative density, according to ASTM D 792 [3], was 2.04 and the nominal diameter 19 mm. Bar mechanical and physical properties—measured during preliminary tests—are summarized in Table 1. All bars were cut into 1200-mm lengths as specified by ACI 440.3R-04 B3 [2]. The concrete mixture consisted of 380 kg of Type 10 cement (corresponding to ASTM I cement), 730 kg of fine aggregate, 1140 kg of coarse aggregate, and 171 kg of water per cubic meter of concrete. The 28 days compressive strengths ranged from 55 to 62 MPa. A high-strength concrete was used to ensure that failure during pullout occurred at the bar–concrete interface, instead of in the concrete, to characterize environmental impact on the interface's long-term performance. These specimens were 200-mm concrete cubes with a single GFRP bar embedded vertically along the specimen's central axis. The bar's bonded length was five times bar diameter (95 mm). Fig. 2 depicted a typical specimen.

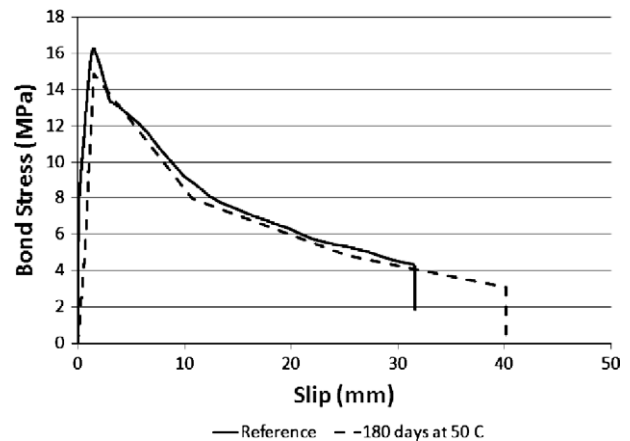
**Fig. 7.** Bond stress-slip relationship for 19-mm GFRP bars.

The free-end slip was recorded directly using the LVDTs (see the typical bond stress vs. free-end slip curve in Fig. 7). The free-end

slip and curve shape were similar for the control and conditioned samples. The bond failures of the GFRP bars were relatively brittle. The sudden free-end slip was accompanied by a significant energy release. During that short time, no data were recorded and the pullout resistance seemed to drop to almost zero. The low post-peak bond strength of the GFRP bars resulted from failure at the interface between the sand coating and core-bar during the pullout test, as depicted in Fig. 6. The smooth-core bar could not provide enough friction to resist to the applied pullout load.
