Characterization of the deterioration of externally bonded CFRP-concrete composites using quantitative infrared thermography

W.L. Lai^a, S.C. Kou^a, C.S. Poon^{a,*}, W.F. Tsang^b, C.C. Lai^b

^a Department of Civil and Structural Engineering, The Hong Kong Polytechnic University, Hong Kong

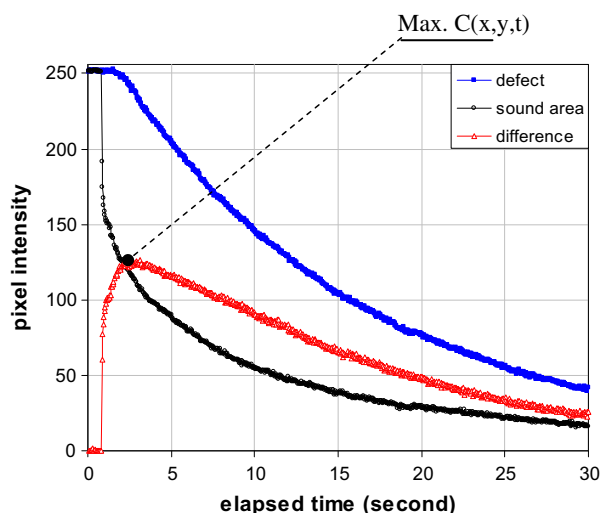
Fig. 2. Thermal history curves of the flaw and sound areas.

The thermal events occur within a defect or a sound area change with time (Fig. 2) because heat dissipation is time-dependent. Thus selection of an appropriate and fixed thermogram at a particular instant is required to extract and define the local flaw boundaries. The selection criteria is generally based on the thermogram with the greatest thermal contrast [10] which is the temperature differential of the flaws normalized over a sound area, as shown in Eq. (1) and Fig. 2. This equation combines the temporal (i.e. t) and the spatial (i.e. x and y) references of the thermal contrast [19,20].

After the extraction of the appropriate thermogram at Max $C(x, y, t)$ as shown in Fig. 2, the thermogram was digitized and the associated geometrical shape of the defect was estimated by the apparent shape deduced from the pixel profile shown in Fig. 3. The latter was found to be close to the steepest temperature gradient computed on the sample surfaces over the defects [15], which is known as gradient computation method [10]. Such method may be processed with a number of algorithms, such as Roberts gradient [18], high degree approximation [10], second order fit [10] and inflection point [4,6]. In this paper, the inflection point algorithm was adopted and modified as two-inflection point algorithm as follows.

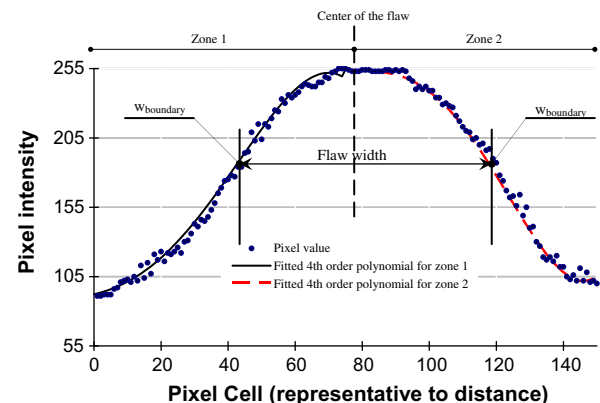
Remark: separation of each pixel cell is 0.4mm. Flaw width in this figure = $80 \times 0.4\text{mm} = 32\text{mm}$.

Fig. 4. Pixel profile from a flaw to sound zone.

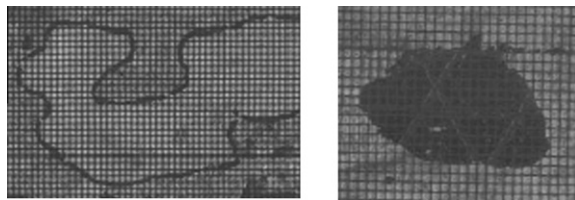
Fig. 5. Interfacial delamination (left) and flaw (right) overlaid by 1 mm² grid for visual imaging method.

the aid of a visual image analysis. For the delaminations, the sizes were determined by: (i) firstly drawing boundaries manually on the CFRP strips (Fig. 5, left); (ii) secondly scanning the CFRP strip overlaid by a transparency printed with 1 mm² grid and converting those in image files; and (iii) finally the defective areas were computed with the aid of a commercially available visual imaging software. For the flaws, the steps used were the same as those for delaminations, except that the first step was omitted because unlike delaminations, the contrast of the flaw boundary was sufficiently clear (as shown in the right side of Fig. 5).

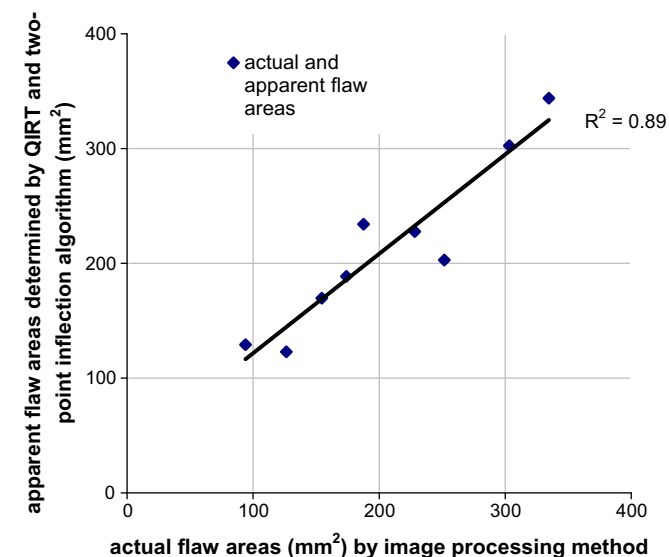
Fig. 6. Comparison between the actual and apparent flaw sizes.

Fig. 6 compares the apparent (determined by QIRT) and actual (determined by image analysis after opening-up) flaw sizes after exposure. The accuracy is 88% and the correlation coefficient is 0.89. These results validate the appropriateness of QIRT and the two-inflection point algorithm methods for the estimation of size of the defects in the CFRP-concrete composite after the exposure period. This is consistent with the results of our previous study based on 17 artificially implanted flaws in the CFRP-concrete composite [6].

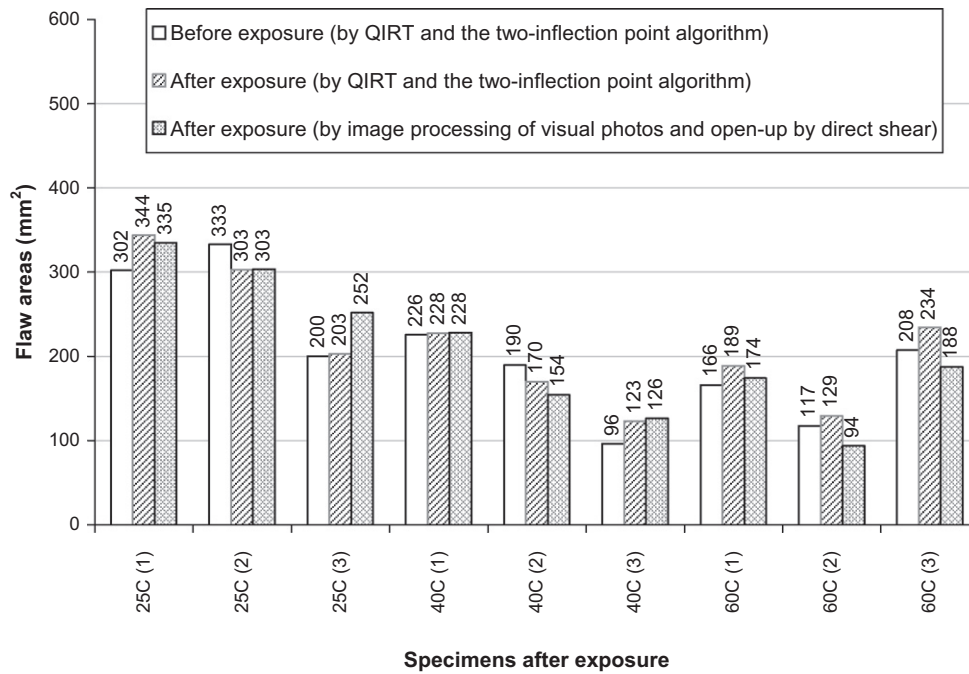
Remark: The specimen ID in x-axis indicates the exposure temperatures in °C in the water bath.

Fig. 8. Comparison of flaw areas before and after exposures.

The results shown in Fig. 8 illustrate the sizes of the sharp-edged flaws were not affected by the exposure condition. It is probably because these flaws were air voids entrapped during the initial laying of the CFRP on the concrete surface and there is no initiation of swelling stress to extend the flaw boundary in the course of exposure.

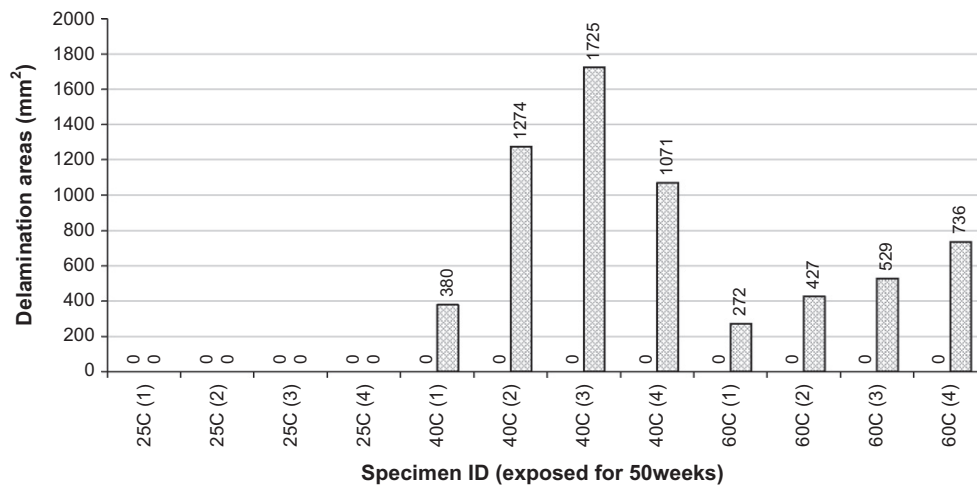
Fig. 9. Comparison of delamination areas after exposures.

On the contrary, elevated temperatures contributed to significant deterioration of the epoxy resin and led to the development of delaminations as revealed in example 2 of Fig. 7. The delaminations were not present before the exposure. Fig. 9 shows the effect of different exposure water temperatures on the development of the delaminations as revealed by open-up examination. Attempts had been made to define the delamination boundaries using the QIRT and two-point inflection method but the results obtained were not consistent with those obtained from the image processing method after opening-up. Therefore, they are not presented in Fig. 9 and a better algorithm is yet to be developed. The inconsistent results were probably due to the relatively flatter pixel profile (illustrated in Table 2) over the delamination areas, when compared with the sharp-edged pixel profile over the flaw areas, rendering clear demarcation of the delamination areas difficult.

observed at exposure temperatures of 40 °C and 60 °C. It is probably because at above a certain critical temperature, water molecules started to act as a resin plasticizer, and the bonds in the polymer (epoxy) chains were disrupted [7,21,22]. The induced swelling stresses may cause permanent polymer matrix cracking, hydrolysis and some degree of fiber-matrix de-bonding [22,23] thus forming the delaminations. The interfacial shear strength would also be reduced [7].
