Delamination tests on CFRP-reinforced masonry pillars: Optical monitoring and mechanical modeling

R. Fedele^{a,*}, M. Scaioni^c, L. Barazzetti^b, G. Rosati^a, L. Biolzi^b

^a Department of Civil and Environmental Engineering (DICA), Politecnico di Milano, Piazza Leonardo da Vinci 32, 20133 Milan, Italy

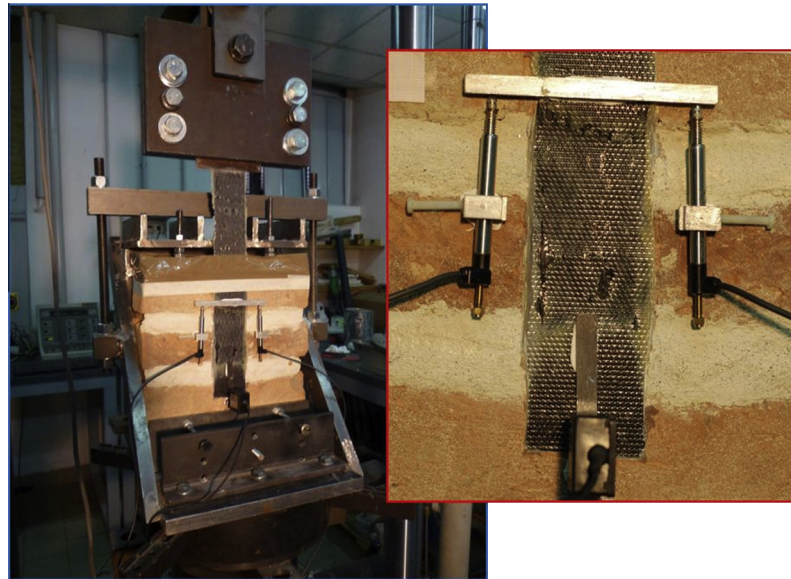
Fig. 2. The testing frame stiffened by diagonal connecting rods, including the reinforced masonry pillar. In the close-up window a detail of the monitored surface is shown, equipped with two LVDTs and a clip gauge.

For the experimental tests, an electro-mechanical testing machine (Instron 8562) with 100 kN maximum capacity was used. Figs. 1 and 2 provide pictures and a simplified scheme of the tested sample and the adopted experimental set-up, respectively. The masonry pillar was fixed by means of a stiffened steel frame, designed to reduce as much as possible rigid body motions. The free end of the CFRP strip was clamped within two bolted steel plates (Fig. 2), and fixed above to the testing machine frame through pinned connections. During the shear test, the relative displacement between the CFRP reinforcement and the masonry pillar, usually referred to as (overall) tangential slip, was enforced by the actuator stroke at the frame basis (see Fig. 2).

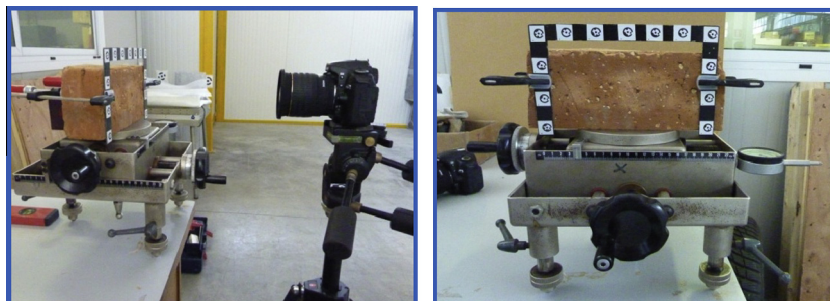
Fig. 4. Validation of optical monitoring system in the laboratory, by means of a dual-axis slide (with accuracy $\pm 10 \mu\text{m}$) and a registration frame with control points.

A preliminary assessment of the optical monitoring procedure was accomplished by the strategy proposed in [2]. As shown in Fig. 4, a masonry brick with a rough natural texture was located on a dual-axes slide. Here (rigid body) displacements with accuracy of $\pm 10 \mu\text{m}$ can be independently prescribed along two directions. As shown in Fig. 4, a registration frame was carefully placed onto the specimen (the same to be adopted later for shear tests). The aim of these tests was to assess the overall system precision also by estimating out-of-plane scale factor λ through Eq. (4), disregarding approximations to be done later in a more complex scenario. Six independent sets of displacements were prescribed to the masonry brick, then the average trajectory of points tracked with DIC was compared to the given steps and discrepancies worked out. Generally, the mean value of discrepancies in each series was not statistically significant. The Root Mean Square Error (RMSE) of all tests was purely based on the standard deviation of measurements, i.e. on their random scatter, and the residuals resulted approximately Gaussian with a vanishing bias. A value of $\text{RMSE} = 15.9 \mu\text{m}$ was found, i.e. equal to $0.19 P_z$ when compared to the footprint of the pixel size on the object. This outcome included both the uncertainty of the homography estimation and the unresolved residuals in the image matching process, and it was affected also by the intrinsic uncertainty of the slide positioning. By extrapolating these estimates to the real experiment set-up,

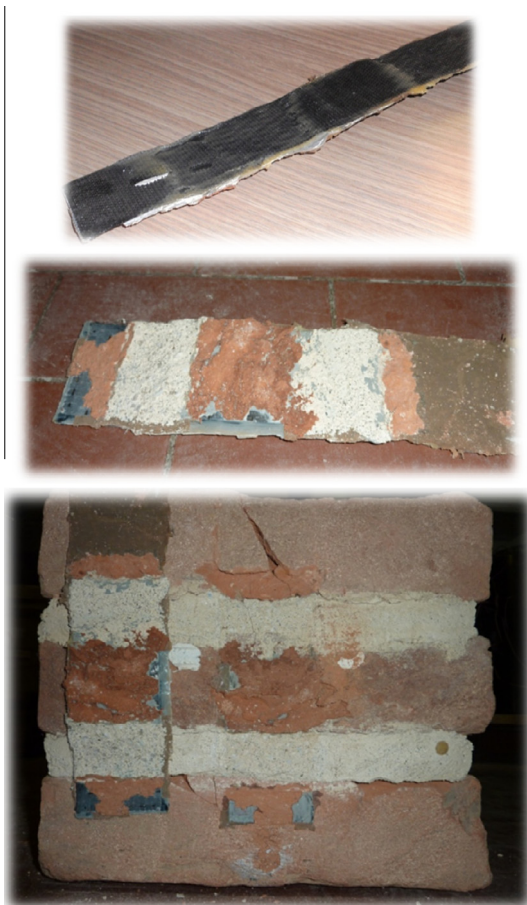
Fig. 12. Post-mortem pictures of masonry pillar and detached reinforcement. Part of the support is still glued to the CFRP strip, thicker in the middle (over the second brick), and indicates the bulk collapse mechanism.

Fig. 11 shows the distribution of tensile damage computed by the finite element model at collapse, drawn on the deformed configuration of the masonry pillar. Post-mortem analysis of the detached reinforcement (see Fig. 12) confirmed the presence of bulb-shaped material glued to the reinforcement, markedly thicker over the second brick (in the middle): the outer contour turns out to be in excellent agreement with the numerical predictions, as showed in the lower detail of Fig. 11. The mortar layers (white colored) still glued to the reinforcement are almost negligible: also this circumstance is in agreement with the finite element analyses, predicting damage along the mortar joints almost exclusively limited to the interface.

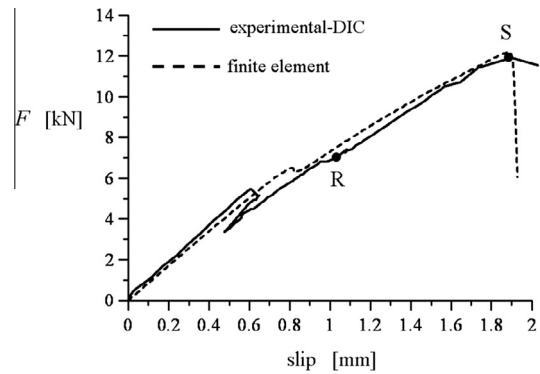
Fig. 13. Response of the single-lap shear test in terms of overall reaction force F as a function of the 'actual' tangential slip reconstructed through DIC (thick line), and its counterpart computed by means of the finite element analysis (dashed line). In the simulations the actual slip is prescribed as boundary condition to the CFRP free end, whilst rigid body motions of the pillar are prevented by ideal constraints.

To compare in a consistent fashion the experimental response (clip-controlled) with the numerical simulations, the ‘actual’ history of overall tangential slip was reconstructed through DIC procedure. To this purpose, since the CFRP free end was fixed to the

machine frame, the relative slip was approximated by displacements in the upper part of the masonry support, estimated by DIC over two regions symmetrically located with respect to the reinforcement and then averaged. Such displacement history was prescribed as boundary condition to the finite element model (at the reinforcement free end), whilst rigid body motions of the modeled pillar are prevented by ideal (i.e. non-compliant) constraints. Explicit finite element simulations of single-lap experiment are therefore slip-driven. In Fig. 13, the reaction force provided by the load cell as a function of the reconstructed slip appears in a rather satisfactory agreement with its computed counterpart, which does not include the wedge crack occurred inside the last brick. The experimental plot still exhibits a pronounced snap-back phenomenon, and the final collapse appears less brittle than in the numerical predictions.

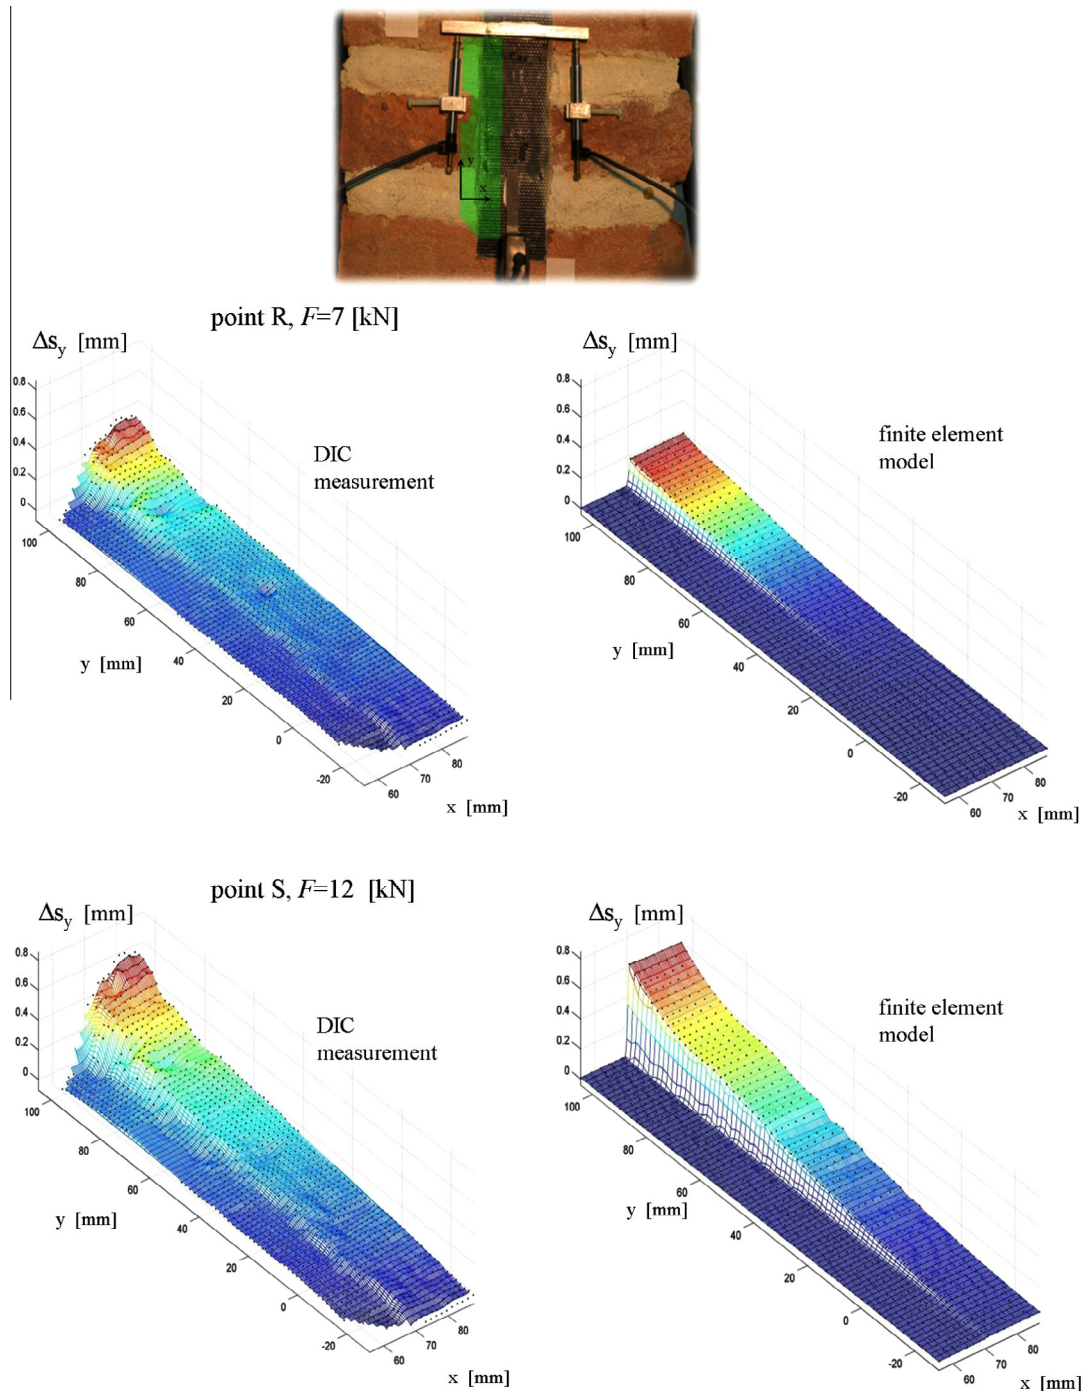
Fig. 14. Relative tangential displacements between the CFRP reinforcement and the masonry support, estimated by 2D DIC at different loading phases during the shear test (points labeled as R and S are indicated in Fig. 13), and their counterparts computed by the finite element model. The upper picture shows the wide field-of-view covered by the camera, and the ROI (green-colored) selected for these analyses. (For interpretation of the references to color in this figure legend, the reader is referred to the web version of this article.)
