Mechanical properties of natural hydraulic lime-based mortars

J. Lanas^a, J.L. Pérez Bernal^b, M.A. Bello^b, J.I. Alvarez Galindo^{a,*}

One hundred eighty different mortars made with a natural hydraulic lime (NHL) and different kinds of aggregates were prepared to be used in restoration works. The factors affecting the mechanical behavior have been studied at long-term test. Compressive and flexural strengths of the specimens were discussed according to curing time, binder/aggregate ratios, attributes of the aggregates and porosity.

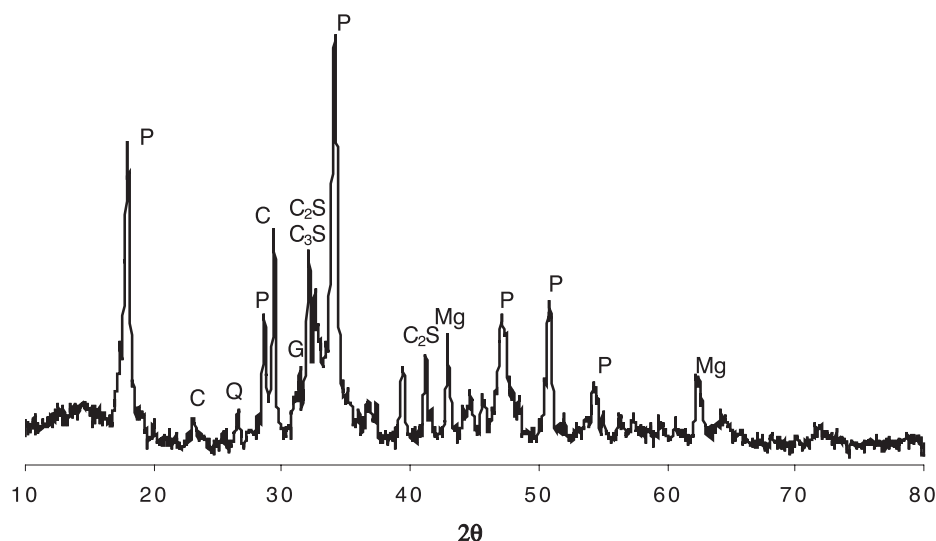
Fig. 1. XRD of hydraulic lime. P: portlandite; C: calcite; Q: quartz; Mg: periclase; C₂S: dicalcium silicate; C₃S: tricalcium silicate and G: gehlenite.

Fumel). Table 1 gives its chemical characterization (according to European Standard [21] and Fig. 1 shows its X-ray diffractogram.

By means of XRD and FT-IR studies, it can verify hydraulic phases in NHL used. The occurrence of C_3S and C_2S is shown in Fig. 1, although the peaks of both compounds appear overlapped. The infrared absorption spectrum of NHL obtained is displayed in Fig. 5. The spectrum shows a strong broad band in the $1200\text{--}800 \text{ cm}^{-1}$ region. Maxima absorptions were checked at around 883, 908 and 940 cm^{-1} , typical for anhydrous tricalcium silicate [18,27]. In addition, strong absorption bands at approximately 850, 1000 and 1112 cm^{-1} (which is also due to the sulfates presence) are attributed to anhydrous dicalcium silicate [18]. C_3S is formed during the sintering process, due to a local overheating at $T > 1250^\circ\text{C}$ [17]. Therefore, the amount of C_3S must be low in NHL, as can be checked with the aforementioned determinations. C_3S hydrates quickly and the strong strength increment at early ages (up to 28 days) can be attributed to this hydration [17].

However, its strength contribution is negligible. In the NHL used, chemical analysis (Table 1) reveals 5.42% of Al_2O_3 . By means of XRD, C_2AS has been checked (Fig. 1). This compound can be determined in hydraulic limes but not in cements [18]. No C_3A has been identified by XRD, but it could be masked due to its low amount. Moreover, C_3A could be masked by FT-IR, but the absorption band at 850 cm^{-1} (Fig. 5) could be attributed at different compounds, C_3A among them. Thus, the occurrence of C_3A cannot be totally rejected.

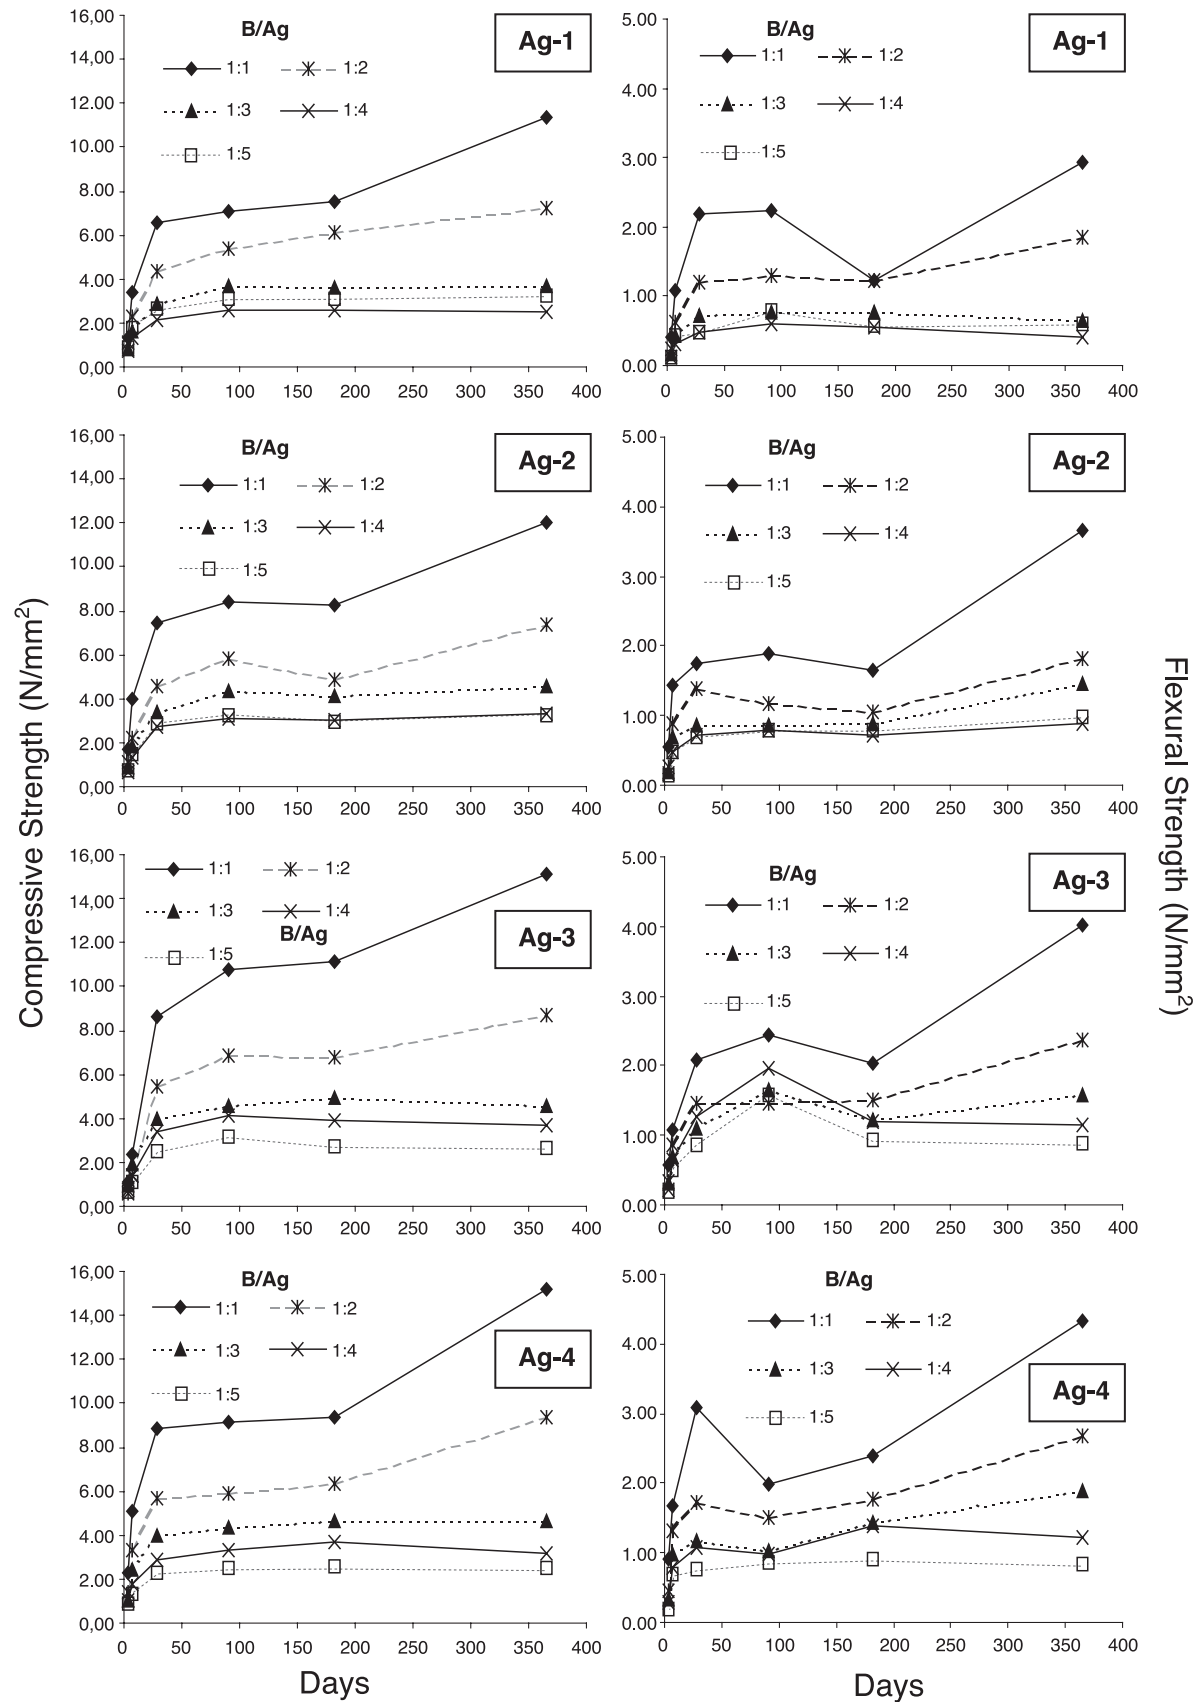
Fig. 3 shows the curves of compressive and flexural strength vs. curing time. From these results, three phases of mortar's hardening clearly differentiated can be checked.

Fig. 3. Strength results in hydraulic lime mortars with different aggregates vs. curing time.

In the early ages (up to 28 days), the mortars extend to 50% of their maximum value of strength, for the mortars with high content in lime (1:1 and 1:2 B/Ag ratios), and close to a 85–90% for the 1:3, 1:4 and 1:5 B/Ag ratios. In this period, the mortars lose the water excess. Fig. 4 shows weight losses in the prepared mortars until 28 days, except specimen 1:1 with higher B/Ag ratio. This 1:1 mortar needs more water than the others to achieve a good workability during its preparation (Table 4), and it shows a weight loss until 91 days.

In this period, the compressive strength of the mortars only increases slightly (Fig. 3) owing to the following: (i)

On the contrary, it can be observed (Fig. 3) that 1:3, 1:4 and 1:5 ratios do not show any strength increment in this last period. The low NHL amount in these mortars can be considered responsible to this fact because (i) the free CH is almost carbonated, as can be checked in Table 5: 1:3, 1:4 and 1:5 specimens show very slight changes in the CaCO₃ (%) / Ca(OH)₂ (%) ratio between 182 and 365 days and (ii) the strength contribution of C₂S is practically negligible on account of this very low amount in these specimens.

In all specimens tested, mortars with more binder content show the highest compressive and flexural strengths (Fig. 3). This fact can be proved at any time and irrespective of the type of aggregate used. A binder decrease in the mortar has reduced its strength.

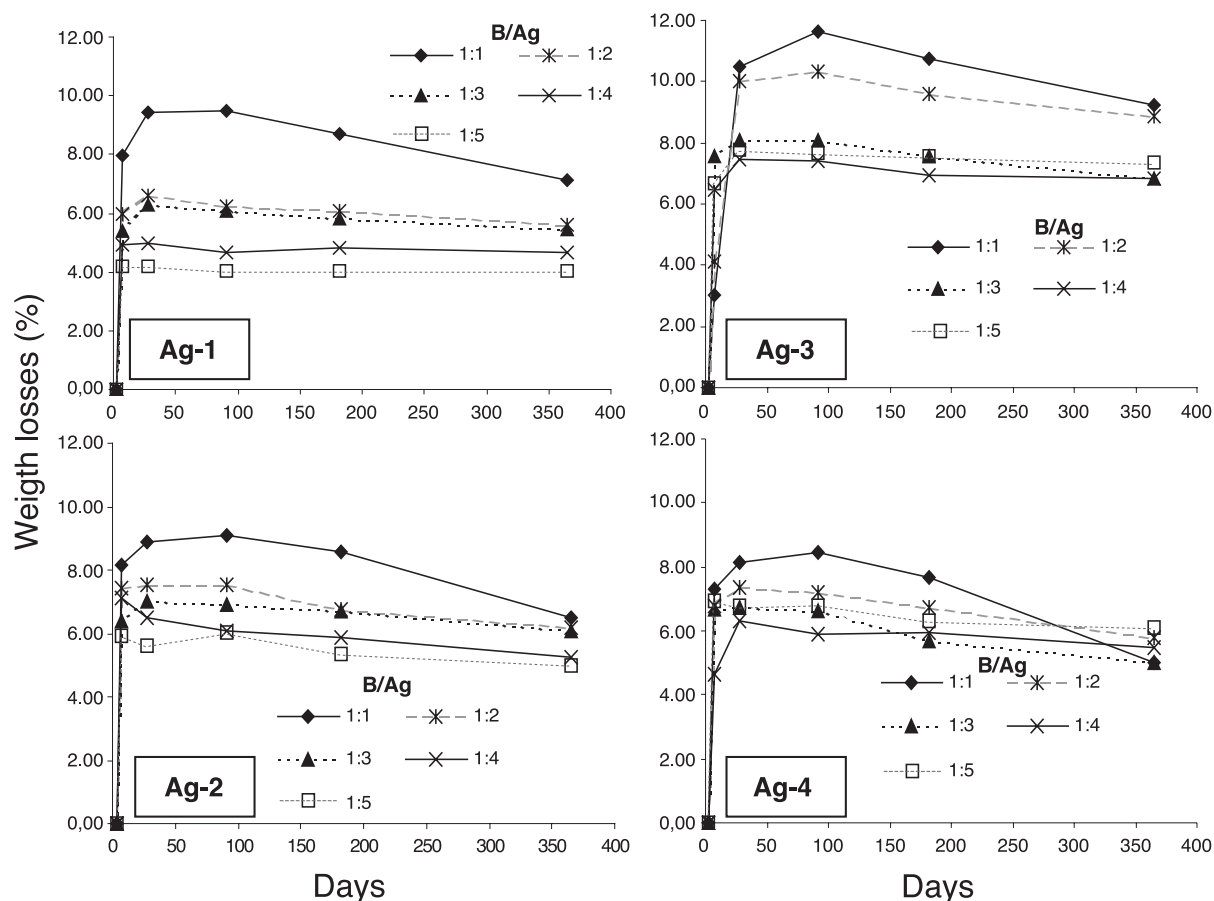
Fig. 4. Weight losses vs. curing time in hydraulic lime mortars with different aggregates.

At medium term (since 28–182 days, approximately), the mortars start to gain weight (Fig. 4). This is due to the fact that the water excess has been eliminated and the mortars have begun the carbonation process (Eq. (1)). However, this weight increment is still low, so it can be

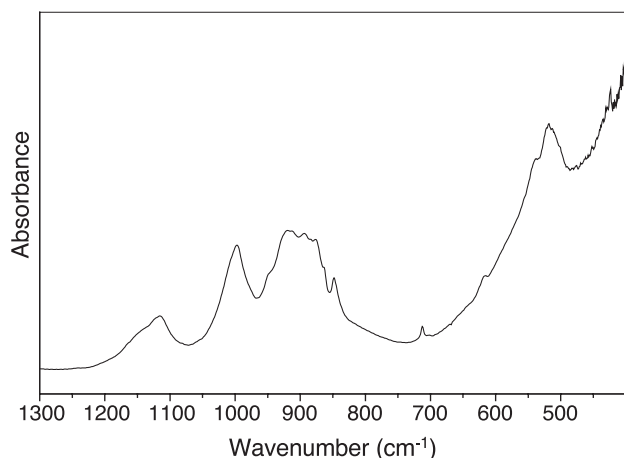
Fig. 5. Infrared spectrum of NHL in the 1300–400 cm⁻¹ region.

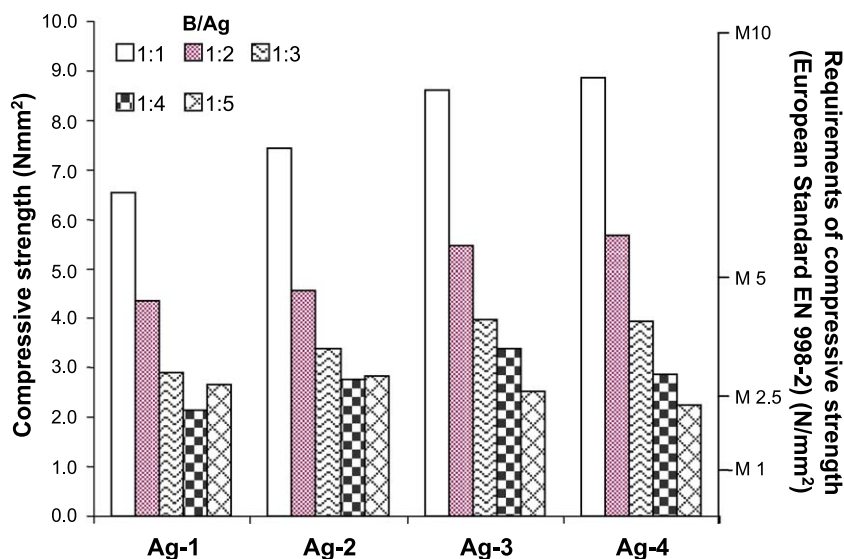
Fig. 6. Comparison between compressive strength results (28 curing days) and European Standard (EN 998-2) values of the different classes of mortar.

To establish the mechanical requirements of the specimens to be used in restoration works, Fig. 6 shows the lower strength for each class of mortar according to the European Standards [33]. At 28 days, all 1:1 B/Ag mortars are M5. For 1:2 B/Ag mortars, specimens made with limestone aggregates (Ag-3 and Ag-4) are also M5. B/Ag specimens with low binder percentage exhibit low strengths.

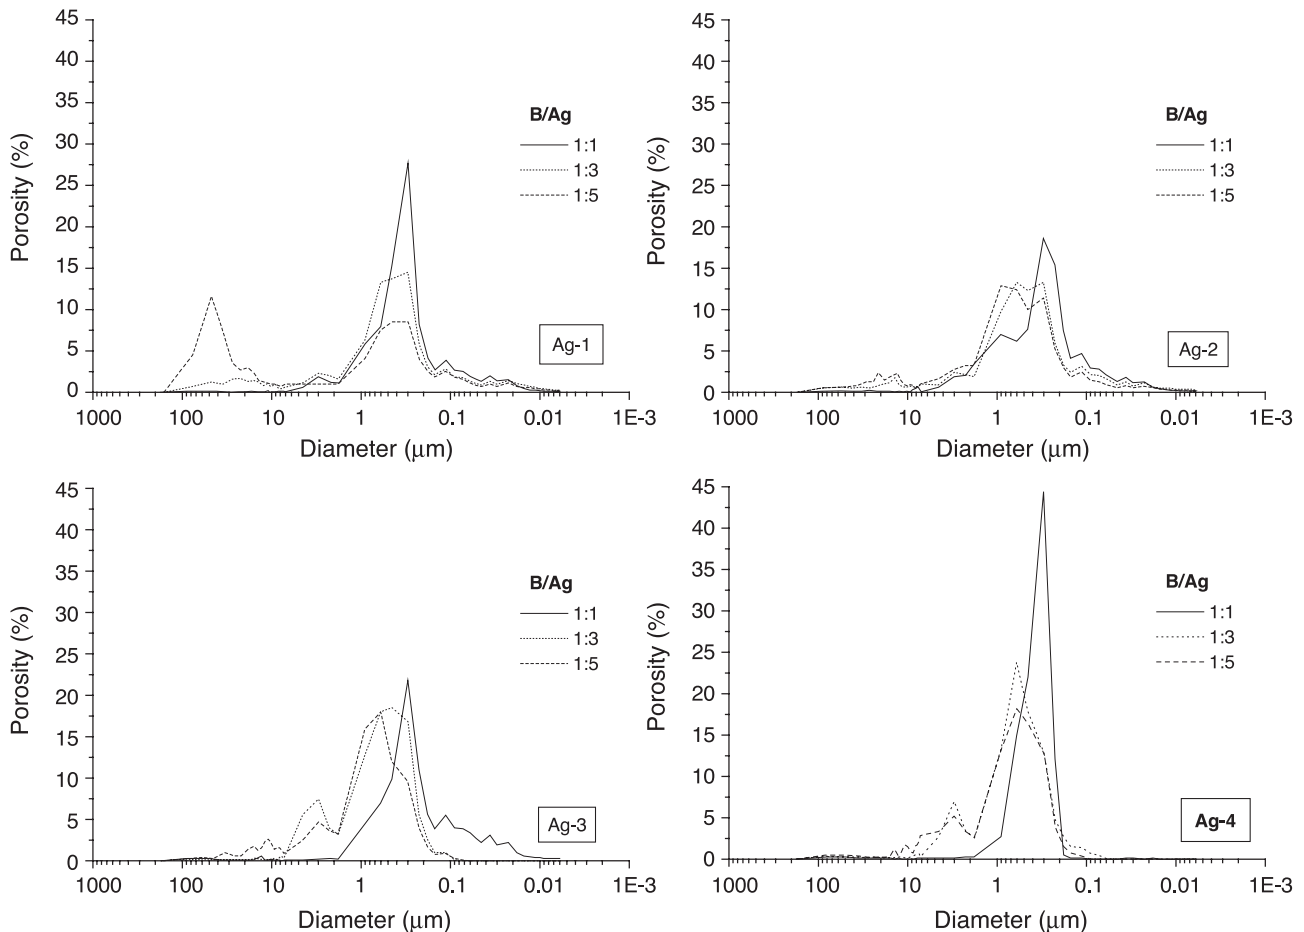
Fig. 8 shows the pore size distribution in specimens with different B/Ag ratios for all the aggregates used, after 1 year of curing. From the results, it can be checked that NHL contribution shows pores around 0.3 μm of diameter. This

Fig. 8. Results from mercury intrusion: pore size distribution for hydraulic mortars with different aggregates at 365 days.

fact can be proved because, in all cases, irrespective of the aggregate used, the highest B/Ag ratios have shown sharper peaks in this pore size. In addition, these specimens, with high binder content, have presented an increment in small diameter pores (0.01–0.1 μm). Pores with diameter between 0.6 and 7 μm are attributed to the limestone aggregates contribution: an increment in this percentage of pores is observed when aggregate amount increases; that is, more aggregate amount means a great peak in this pore size. Moreover, in Ag-1 and Ag-2, this fact occurs due to the chemical composition of these aggregates, with a certain amount of calcite (Table 3).

In Fig. 8, it can also be observed that large pores (diameter between 7 and 100 μm) show a percentage increment when aggregate content rises. These large pores have evident mechanical repercussions: the strength values decrease when the B/Ag ratio decreases, i.e., when the percentage of large diameter pores increases. The specimens with Ag-1, especially the 1:1 B/Ag ratio, present the highest values of large pores, (peak around 50 μm). These pores can be due to a bad cohesion between the binder and the aggregate. The rounded shape of this Ag-1 does not allow a good adhesion at the interface of aggregate–matrix, and the strength drop. This influence of the aggregate shape on the strength is also proved by Ag-2 results (Fig. 8). No peak from pores with diameter of 50 μm is observed, although very similar composition between Ag-1 and Ag-2 was established. Therefore, as discussed in Section 3.3, the shape of the aggregate is responsible for this increment of large pores: Ag-2 is angle shaped, and it allows a better packed structure. In addition, Ag-3 and Ag-4 are angle shaped, and no large pores are checked. For Ag-4, its grain size distribution leads to a lower amount of pores than Ag-3, with diameter between 7 and 100 μm . The small grain size in Ag-4 contributes to a more compact matrix embedded with aggregate grains. Fig. 9 shows a good cohesion at the binder–aggregate interface in SEM observations.
