Experimental characterization of the self-healing of cracks in an ultra high performance cementitious material: Mechanical tests and acoustic emission analysis

S. Granger^a, A. Loukili^a, G. Pijaudier-Cabot^{a,*}, G. Chanvillard^b

Abstract

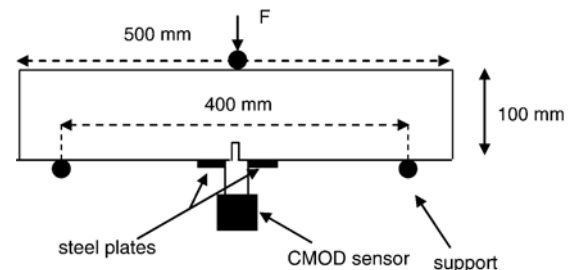
Fig. 1. Three points bending tests configuration.

The specimens are loaded under three points bending. The tests are notch opening controlled with a constant rate of $0.05 \mu\text{m/s}$. The crack mouth opening displacement (CMOD) is measured (Fig. 1), with a sensor placed between two steel plates stuck on each side of the notch on the bottom face of the specimen. The aim of this preliminary phase is to get a controlled cracking of the specimen. The objective of the study is to quantify the mechanical behaviour of healed concrete specimens, so, it was decided to aim a single residual crack width of approximately $10 \mu\text{m}$, which permits to get a fast self-healing. It is worth noting that the influence of the crack width [4,12] on the phenomenon is not investigated here. Pre-cracking is performed in the post peak regime: after having reached the peak load (comprised between 3 and 4 kN), unloading is performed when the applied force reaches 2 kN, which

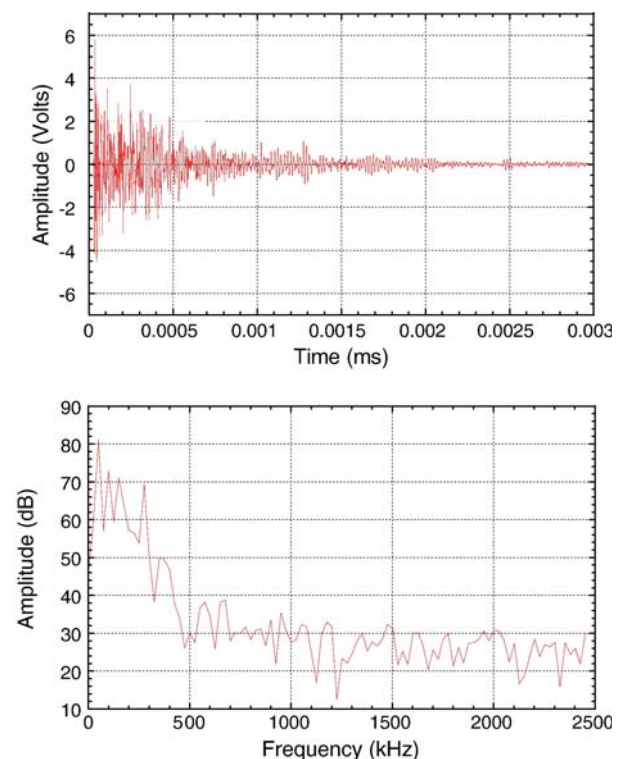
Fig. 2. Typical waveform of an acoustic event (top), and corresponding Fourier transform (bottom).

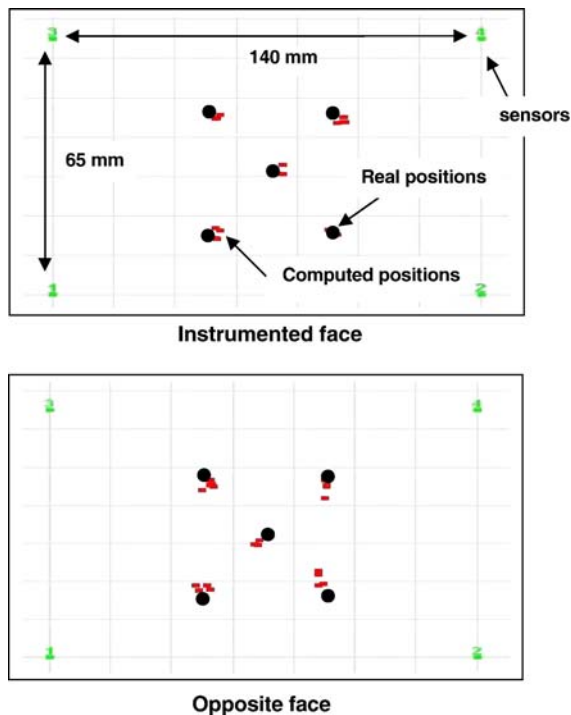
Fig. 3. Accuracy of the 2D planar localisation scheme measured with a Hsu–Nielsen source: a) source placed on the instrumented side of the beam; b) source placed on the back surface of the specimen.

location (based on 20 simulations on 5 different places in the location area) is ± 3 mm as shown in Fig. 3a. This is correct in comparison with the diameter of the transducers (15 mm). Note that this is the accuracy with respect to a standardised acoustic source, and not to real acoustic events due to microcracking. It is expected that the accuracy should deteriorate as the amplitude (or energy) of the events decreases and is not as strong as the standardised source. Again since weak events will be further filtered out, one may consider that the accuracy does not deteriorate a lot in the present analysis.

Since we use a 2D planar localisation algorithm, it is important to determine the effect of the specimen thickness. In fact, this algorithm provides a projection of all the events onto a single plane. Hence the projection may generate a bias and some additional error in the localisation scheme. The same accuracy tests as above have been conducted on the opposite side of the specimens, which is not instrumented. Results are reported in Fig. 3. We can observe that the accuracy (with respect to a standardised acoustic source) is about the same and does not depend on the face of the specimen on which the source is located. Therefore, we may conclude that the bias induced by the specimen thickness is within the accuracy of the localisation algorithm.

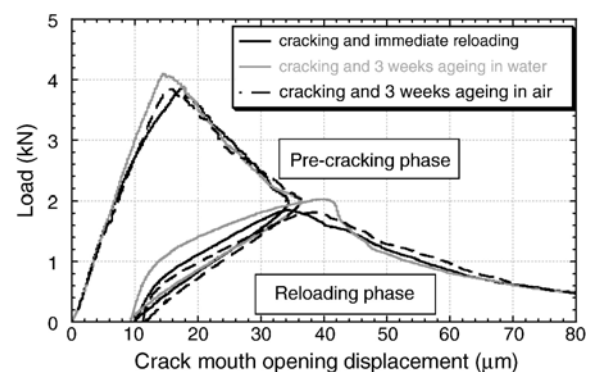
Fig. 4. Mechanical behaviour of a specimen cracked and immediately reloaded, of a specimen cracked and aged 3 weeks in water before reloading, and of a specimen cracked and aged 3 weeks in air before reloading — pre-cracking and reloading phases.

Three kinds of mechanical results are presented in Fig. 4. These are curves for a specimen pre-cracked and then immediately reloaded, and for specimens cracked and aged during 3 weeks (before reloading) respectively in water and in air. The objective of this figure is to show the effect of storage in water, and to compare with the storage in air and with the immediate reloading of the specimen. The curves display the applied load versus the crack mouth opening displacement. Each curve presents two parts: the pre-cracking phase, consisting in loading and unloading when the applied load reaches 2 kN in the post peak regime, and the reloading phase, immediate or after ageing. The reproducibility of the pre-cracking phase of the tests can be seen on this figure. It also shows that the cracked specimen immediately reloaded, and the

specimen aged in air, have the same mechanical behaviour, which is the typical reloading after cracking. On the contrary, there is a difference with the mechanical behaviour for the specimen stored in water, on the reloading stiffness and the reloading peak load especially. This result confirms that water is needed for the self-healing phenomenon.

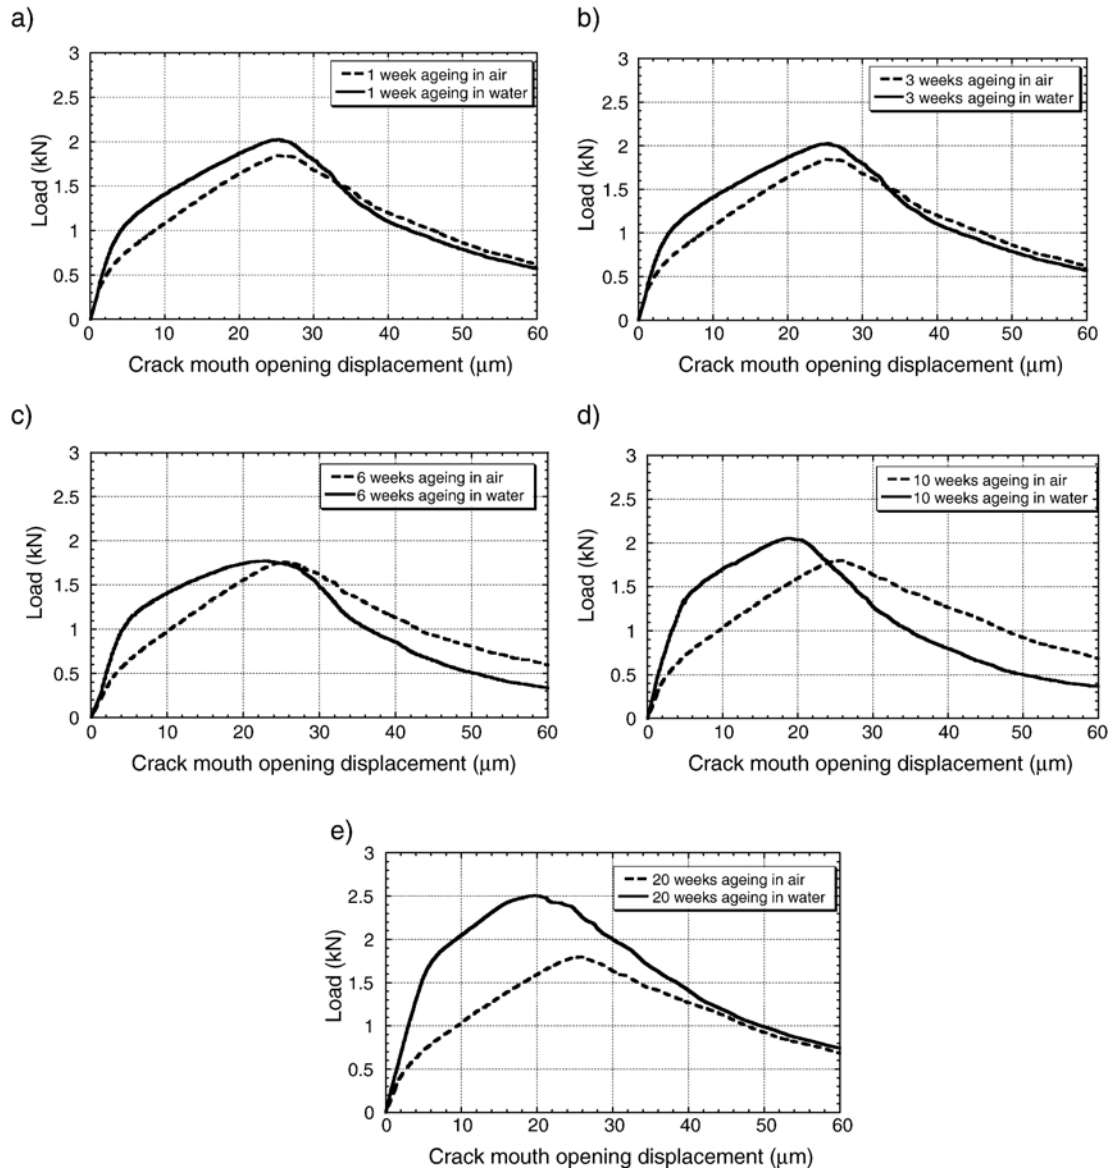
Fig. 5. Mechanical reloading behaviour of aged specimens for different ageing times — comparison ageing in water and ageing in air; average curves: (a) 1 week, (b) 3 weeks, (c) 6 weeks, (d) 10 weeks, and (e) 20 weeks.

We now have to discuss the influence of the ageing time, which is, of course, an important parameter. Fig. 5 presents the average reloading curves for three specimens stored in water and for three specimens stored in air, for the 5 different periods of ageing. For the sake of clarity, only the reloading parts of the total curves are presented. The CMOD at the beginning of the tests is set to 0, in order to have the same initial state, but in reality we should have the value of the residual CMOD at the end of the pre-cracking phase.

We can notice that specimens stored in air exhibit very similar mechanical behaviours for the 5 periods of ageing. It

means that air has no influence on the mechanical properties of cracked specimens, even for a long period of ageing. After the usual hysteresis at the beginning of reloading (until 0.3 kN), the reloading part corresponds to the re-opening of the existing crack until the peak load, followed by the continuation of the crack propagation. On the contrary, there is a clear evolution of the mechanical behaviour of specimens stored in water with the time of ageing. The reloading stiffness is not the same as for specimens aged in air, and it increases. There is also a slight improvement of flexural strength and a change in stiffness in the pre-peak phase, which evolves with time.

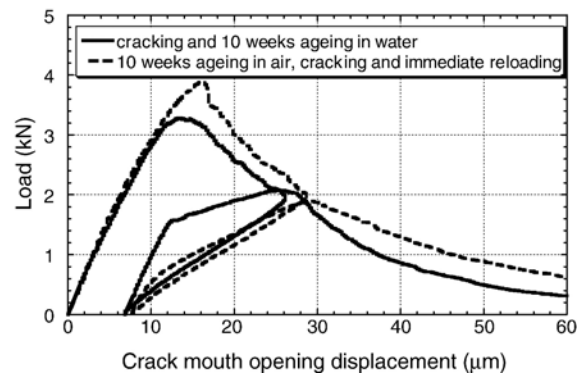
Fig. 6. Average mechanical behaviour of reference specimens (stored without crack in water for 10 weeks, and then cracked and immediately reloaded) and of cracked specimens stored in water for 10 weeks before reloading.

In order to get a confirmation that these observed mechanical behaviours are due to the self-healing of the pre-existing crack and not to the evolution of concrete itself in water, Fig. 6 presents the average mechanical result of tests conducted on specimens which have been stored in water for 10 weeks, and then cracked and immediately reloaded, in comparison with the average mechanical behaviour of specimens pre-cracked and aged 10 weeks in water. It shows that storage in water without crack does not improve the mechanical properties of the specimen. We have the same mechanical behaviour as those of a non-aged specimen cracked and initially reloaded: there is no curing effect by storing in water, and it is a consequence of the thermal treatment. Indeed, the hydration reactions have been

significantly slowed down and final porosity has been reduced due to the pozzolanic reaction [9]. Water can not penetrate significantly in concrete, except through cracks. So the evolution of the mechanical behaviour established for cracked specimens stored in water can indeed be explained by the self-healing of cracks phenomenon, and not bulk material improvement upon ageing.

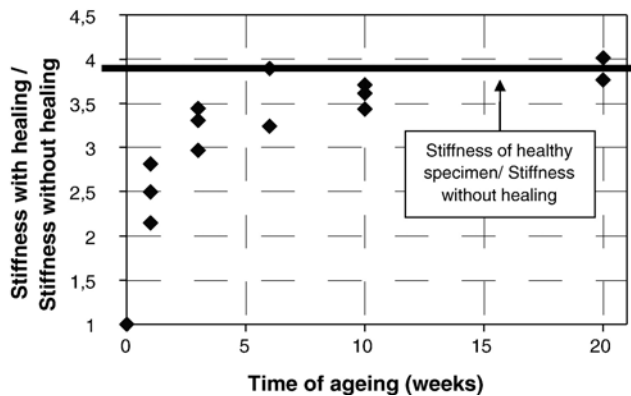
Fig. 7. Evolution of the ratio between the reloading stiffness with healing (in water) and the reloading stiffness without healing, as a function of time of ageing — comparison with the average stiffness of healthy specimens.

Fig. 7 shows the evolution of the ratio between the reloading stiffness with healing, and the reloading stiffness without healing, as a function of the ageing time. Stiffness is calculated by a linear regression for load ranges from 0.4 kN to 0.8 kN. It is noticeable that there is a fast recovery by self-healing, and this stiffness tends to those of healthy specimen, which is represented on the graph by the straight line. These results can be explained by the fact that new products are formed in the crack, especially, if we consider the low water/cement ratio, new C–S–H. These crystals make a bridge between the two faces of the crack and progressively fill it. The stiffness of these crystals is certainly close to those of primary C–S–H (formed by normal hydration) and when the crack is fully filled, the global stiffness of the specimens can reach the initial one, before damage.

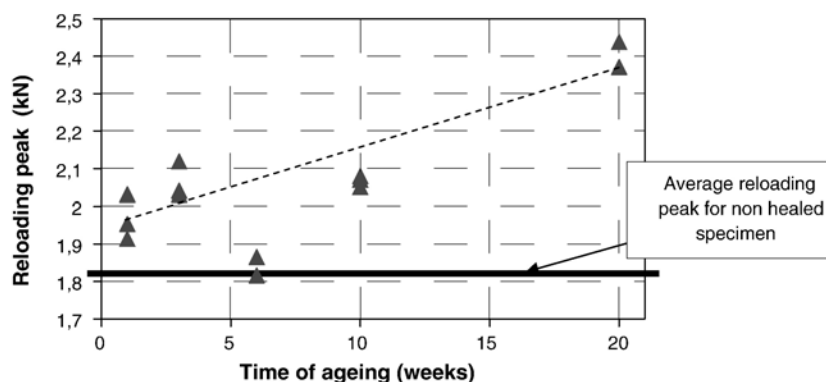
Fig. 8. Evolution of the reloading peak for healed specimens (storage in water) with the time of ageing — comparison with the average reloading peak of non-healed specimen.

Concerning the flexural resistance, Fig. 8 represents the evolution (with the ageing time) of the peak load upon reloading for healed specimens. It shows that self-healing provides a slight improvement of the resistance, compared with the resistance of non-healed specimens. Nevertheless, the initial flexural resistance is not reached and this could be explained by the fact that crystals formed in the crack bridge it but can not form the complex microstructure which provides the strength of the material initially, especially all the links between C–S–H. We may wonder what could be the evolution of the mechanical behaviour for longer ageing periods. It is probable that constrained crystal growth in between the crack surfaces and within the FPZ may not provide the same strength as for the initial hydration of the material.

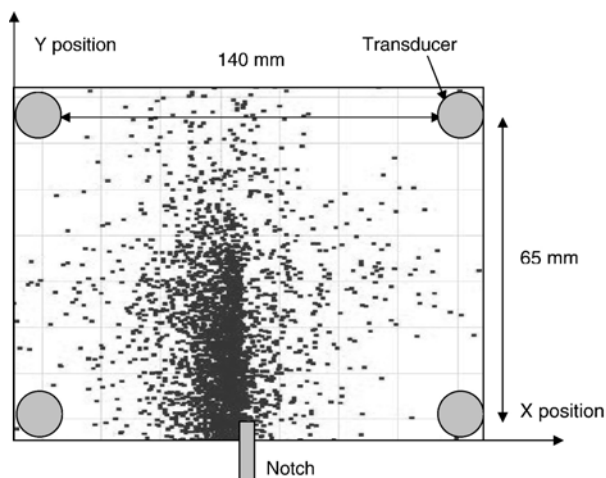
Fig. 9. Microcracking map of a specimen after the pre-cracking phase — result without all events.

Fig. 9 presents the typical microcracking map of a specimen, just after the pre-cracking phase. The transducers which form the rectangular array are represented in the corners, and the other points are the microcracks detected. It shows a very dense area of acoustic events, due to the development of the fracture process zone. Even in the particular material used for this experimental program, the fracture process is not limited to the macrocrack but also spreads around it.

In order to have a more accurate location of the macrocrack in this area, which is of interest if we want to locate the microcracking of new crystals in this crack during the reloading phase, selection of the signals detected is necessary. Otsuka and Date [20] have shown that 95% of the dissipated acoustic energy is located in the fracture process zone, and that the less energetic events contribute only a little to the fracture of concrete. After having selected the event with the most important energy (energy calculated by integrating the whole signal), we have chosen to eliminate the events with an energy less than 2% of this maximal energy. Doing this, we keep only the most energetic events, associated with fracture. It also improves accuracy, because the most energetic signals are located with a better accuracy. The selection energy criterion is thus set to 1000 atto-Joule (aJ). Fig. 10 presents the result of this data processing. Compared to Fig. 9, we can see that most of the events are located in a narrower band which follows more closely the macrocrack surface. In 2D AE localisation analysis, a warped crack surface, or a rough crack surface, when projected onto a plane provides a band of events occurring within the specimen thickness. This systematic bias of a few

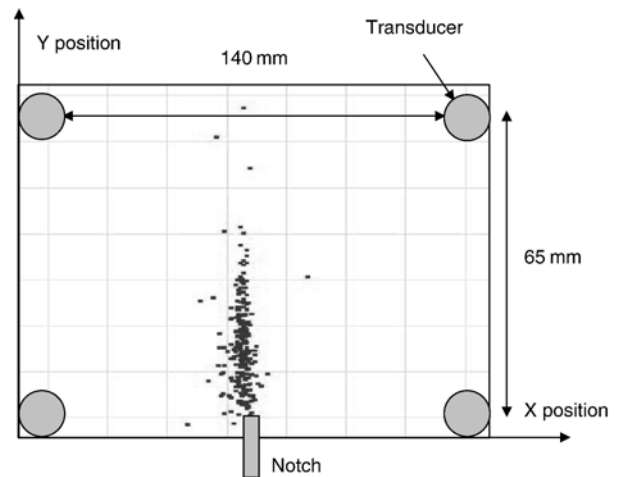
Fig. 10. Microcracking map of a specimen after the pre-cracking phase — result with selection in energy: events with an energy higher than 1000 aJ.

millimeters (maximum 3 to 4 mm) should be added to AE localisation accuracy. In Fig. 10, the maximum thickness of this band is about 10 mm, still a bit larger than the crack surface warping and crack roughness, but in the present cementitious material some FPZ of finite size should be expected.

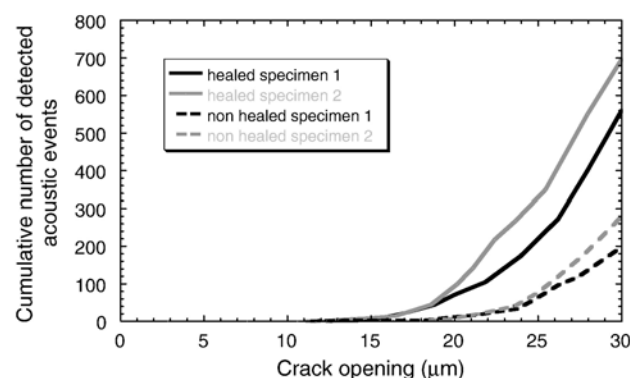
Fig. 11. Cumulative number of acoustic events during the reloading phase for healed and non-healed specimens.

According to the same data processing of the AE as in Section 4.1, we consider first the cumulative number of detected events. Fig. 11 shows the evolution of this number with crack opening for four specimens cured during 10 weeks. The reloading phase corresponds to crack openings less than 20 μm approximately and there is a significant difference between healed and non-healed specimens responses in this range. For crack openings larger than 20 μm , the crack length is greater than the initial one, prior to healing. The number of events recorded on healed specimens (cured into water) is at least twice the number observed for unhealed specimens.

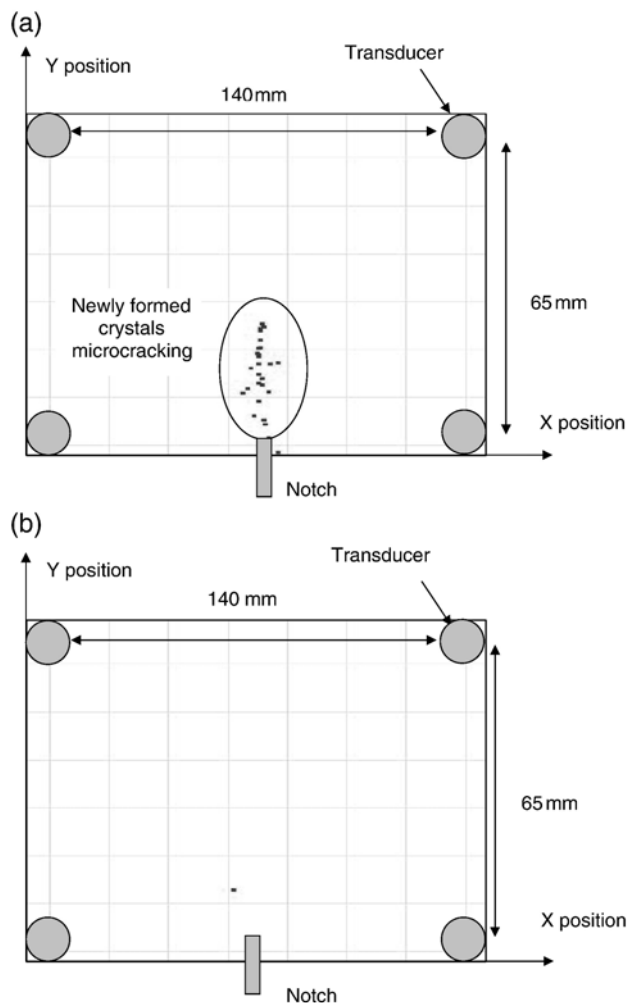
Fig. 12. Microcracking maps, during the reloading phase (until 18 μm — pre-peak regime) of specimens aged for 10 weeks; (a) ageing in water, (b) ageing in air.

Fig. 12 presents the maps for a specimen aged in water and for a specimen aged in air, both during 10 weeks. It is noticeable that acoustic activity appears for the healed specimen in the region of the initial crack, while nearly nothing is detected for a non-healed specimen. In view of the mechanical results which exhibit stiffness and strength recovery, one can say that in the first case, there is a damage of the newly formed crystals in the crack, and in the second case, there is only the re-opening of the existing crack, with very little acoustic activity (some due to friction probably). Note that for non-healed specimens, performing the same AE localisation analysis without removing the less energetic events would still provide little acoustic activity, less than that observed for healed specimens.

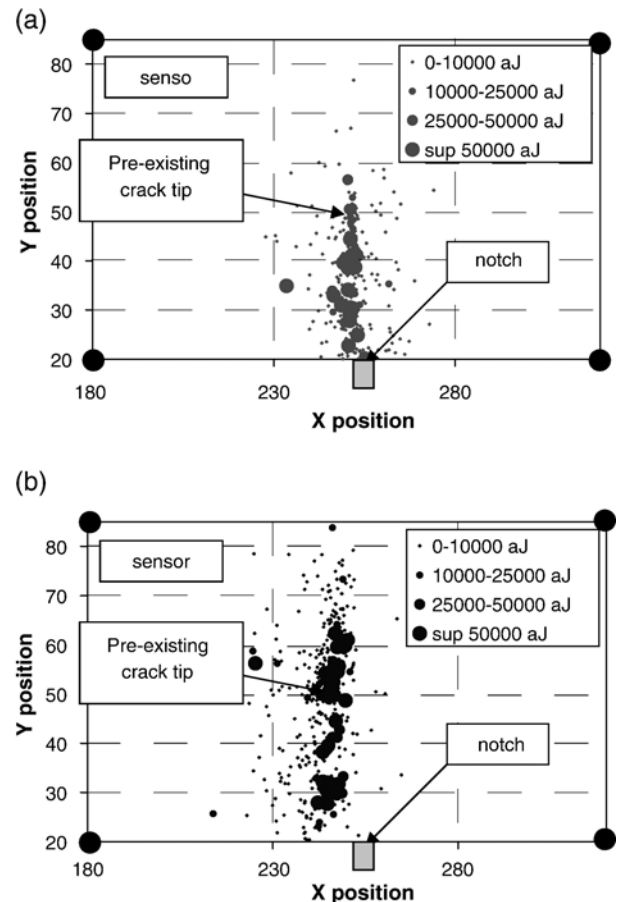
Fig. 13. Energy location maps at 90% of the peak load in the post peak regime; (a) healed specimen, (b) non-healed specimen.

We may now consider the comparison during the reloading phase, not at the same CMOD, but at the same load level. Results at 90% of the peak load, in the post peak regime are analysed. Fig. 13 represents the location maps in terms of energy. Points representing the microcracks are plotted according to their acoustic energy in aJ (the analysis is carried out after having removed less energetic events): the bigger the point, the larger the energy. If we now sum these energies for events located below and above the pre-existing crack tip (which is for

height of 50 mm from the bottom face of the specimen), we can notice that 97% of the acoustic energy dissipated until 90% of the peak load is located in the pre-existing FPZ, for the specimen which has been stored in water, although it is 48% for a non-healed specimen. This acoustic energy dissipated in the crack for a healed specimen should be due mainly to microcracking of newly formed crystals inside the initial crack. Friction would provide some acoustic activity, but probably not the stiffness and strength recovery that was observed on the mechanical response at the same time. For the non-healed specimen, the acoustic activity is due to further propagation of existing microcracks (note that the specimen is again in the post peak regime).
